Michael A. Berardi  
Director  
Service Engineering Operations  
Ford Customer Service Division

August 9, 2013

**SUBJECT:** **DEMONSTRATION / DELIVERY HOLD - Application Performance Upgrade 12A04**  
**– Supplement #4**  
Certain 2011-**2014** Model Year Vehicles Equipped with SYNC® and MyFord/MyLincoln Touch™  
Application Performance Upgrade

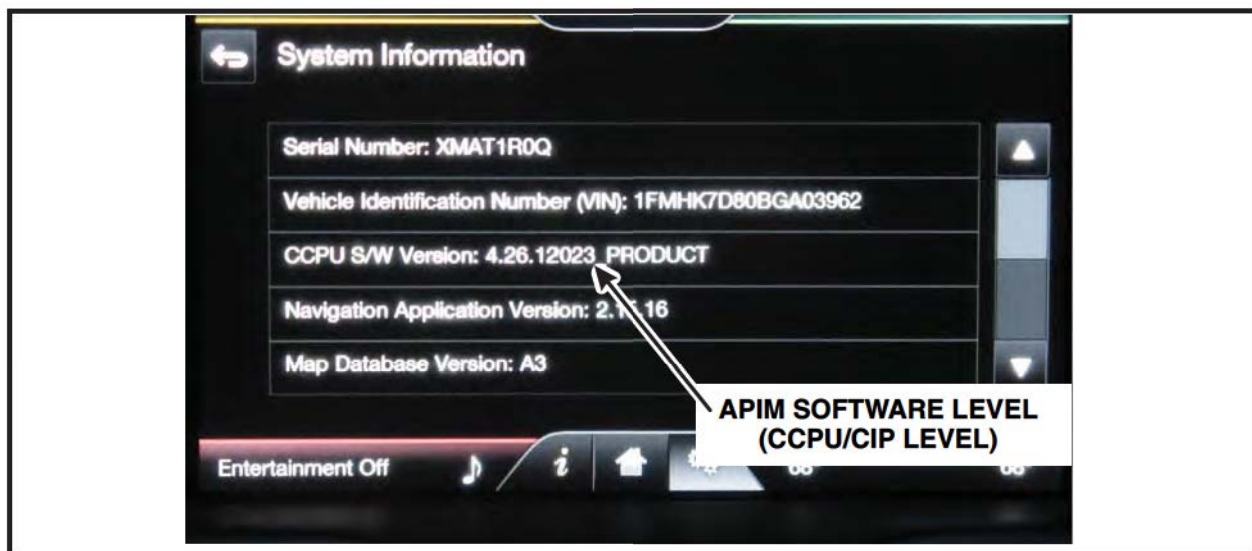
FIGURE 1

1. Determine the vehicle's current Accessory Protocol Interface Module (APIM) software level (CCPU/CIP level). See Figure 1.
  - a. On the Front Display Interface Module (FDIM), select "Menu" then select "Help".
  - b. Select "System Information".
  - c. Note the last five digits of the CCPU/CIP#. See Figure 1.
- If the last five digits are "13171" or higher, the APIM is at the latest level. Return the system to the home screen, and release the vehicle to the customer.
- If the last five digits are less than "13171" (e.g. 12023), proceed with the Service Procedure.

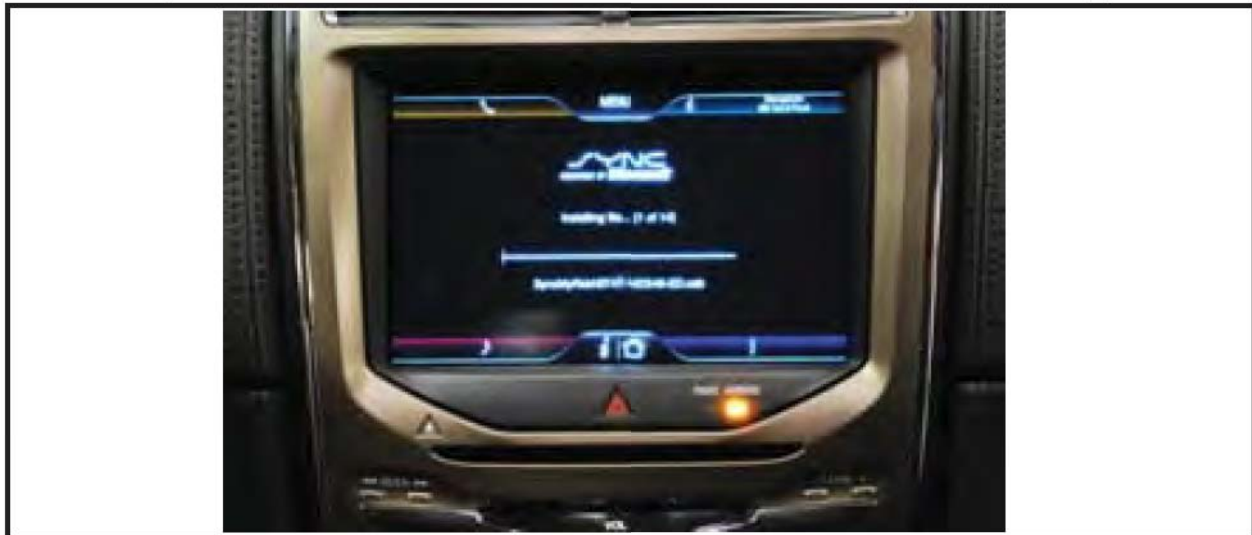
FIGURE 2

1. Start the vehicle so that the battery saver mode will not activate while performing the reprogramming procedure.
2. Wait for the system to boot up, remove any connected devices, and for the home screen to appear on the FDIM.
3. Install the USB drive containing **BD/13171/V3.6.2** software level into one of the vehicle's USB ports. The reprogramming procedure will start automatically. See Figure 2.

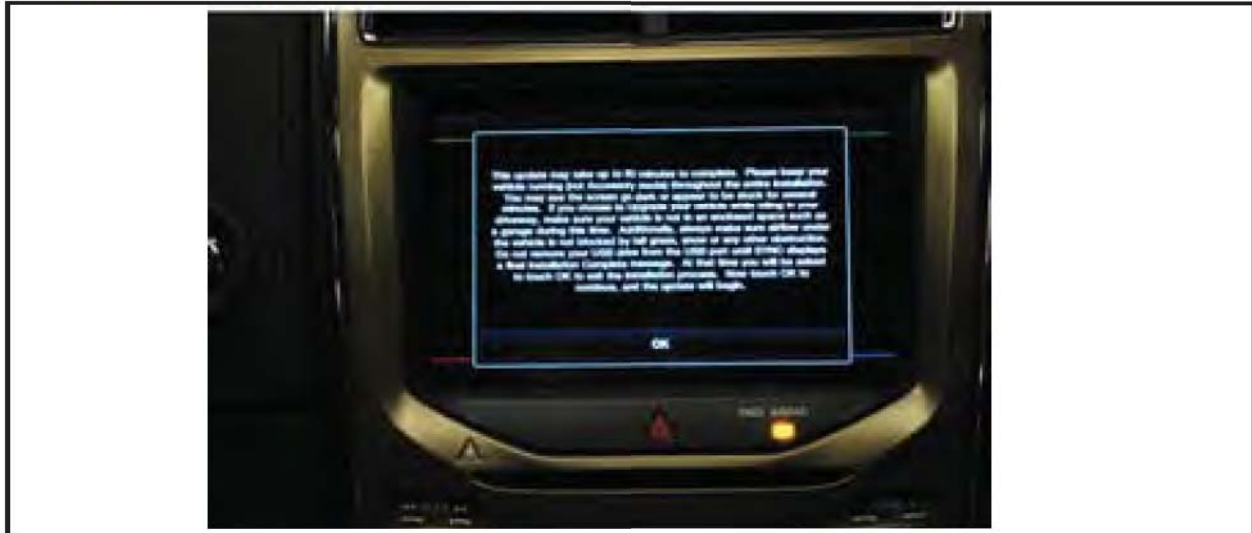
FIGURE 3

4. After the installation starts, a verbal and onscreen message will confirm that the installation is about to start, tap "OK". See Figure 3.

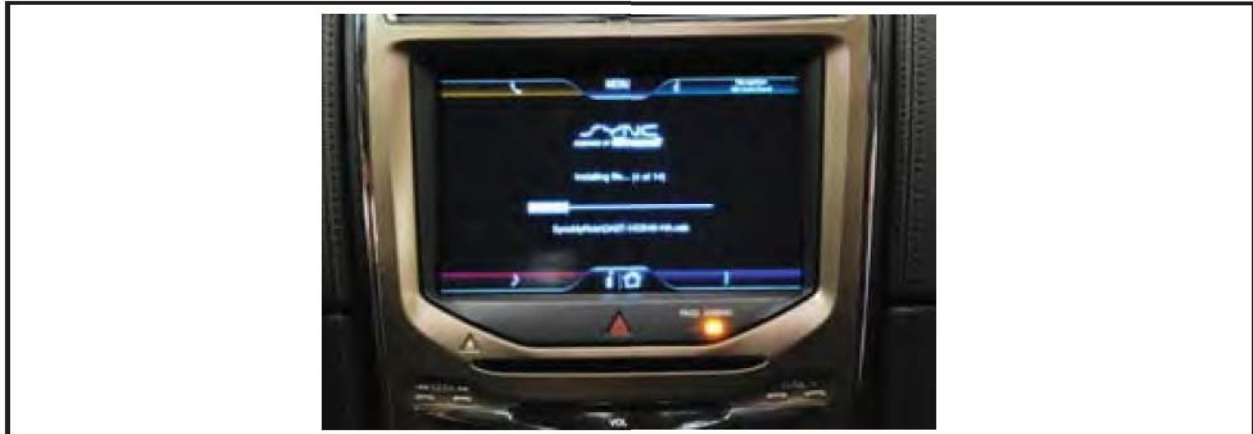
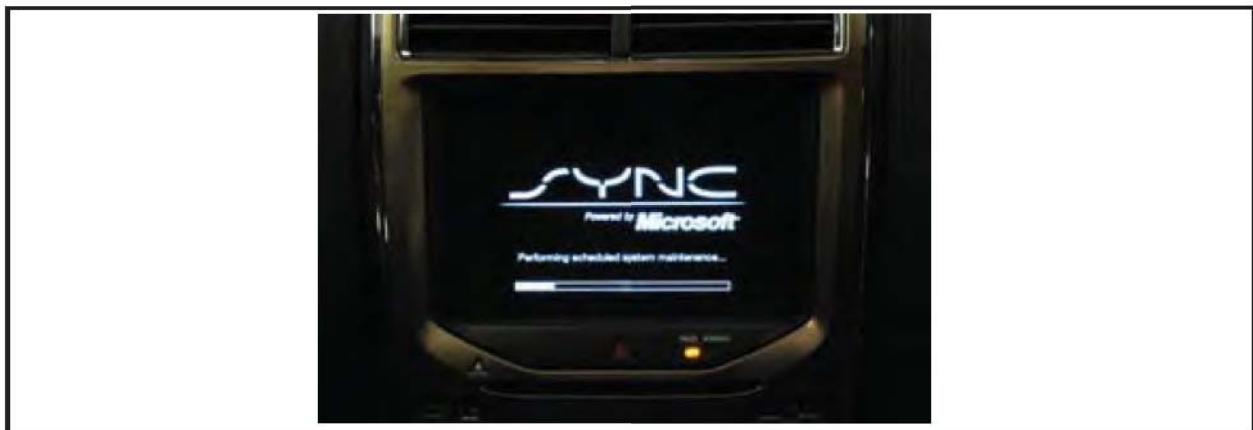
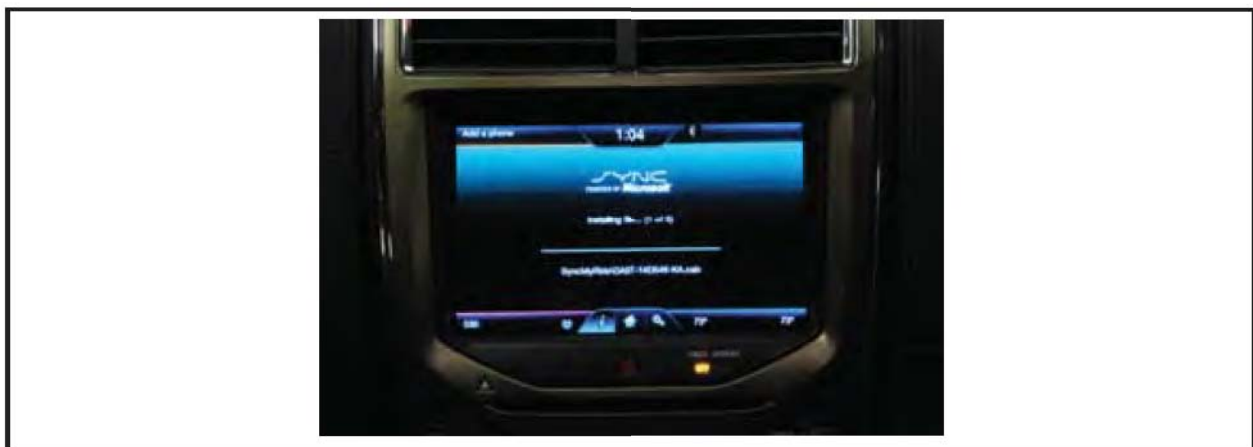
5. During the reprogramming process a series of screens may appear and/or the system will reboot with a blank screen. See Figures 4, 5, and 6.

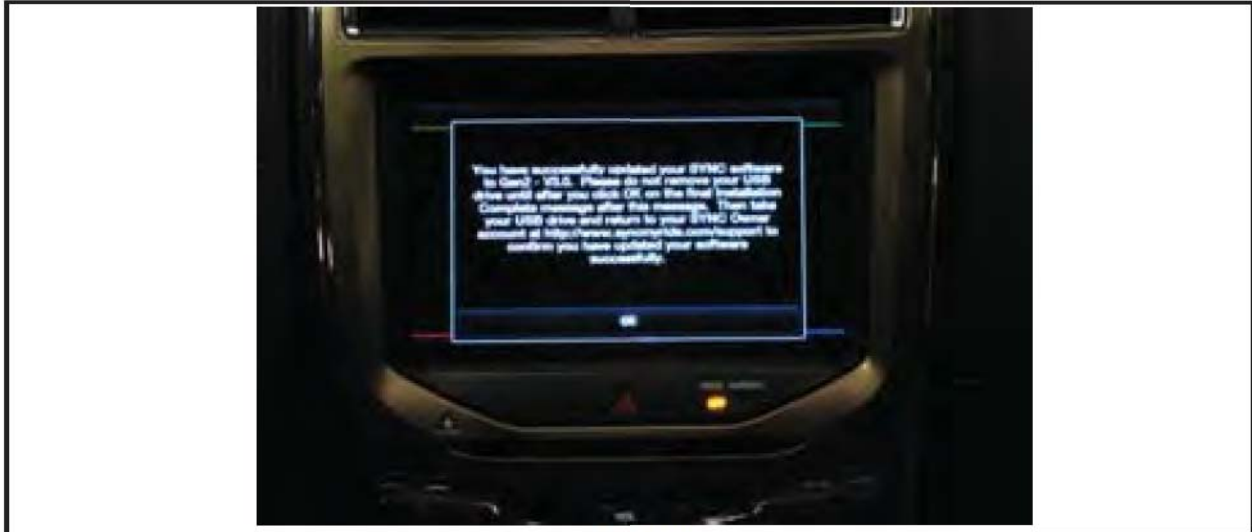
FIGURE 7

6. When the programming is completed, a screen stating the software update was successful will appear, tap "OK". See Figure 7.

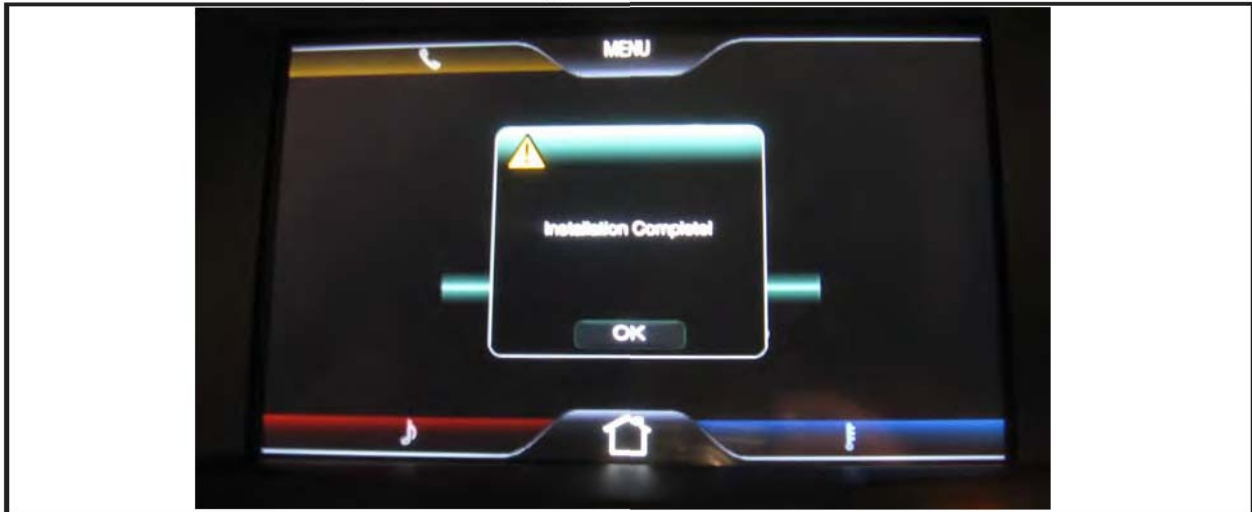
FIGURE 8

7. When the "Installation Complete!" screen appears tap "OK". See Figure 8.
