# Service Bulletin

Bulletin No.: 03-08-48-006J

Date: December, 2014

**Subject:** Repair Information for Reconnection of Rear Window (Defroster) Contact or Tab

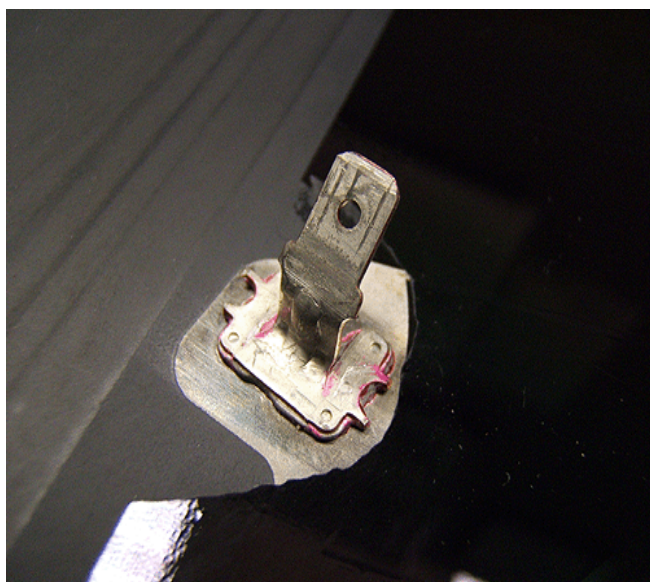
2000227

6. The above illustrates an ideal finished solder joint. Additional stray solder will not harm the performance of the bond; however, while it is unlikely that customers may refer to the appearance of the rear window defroster and its components as a positive styling feature of the vehicle interior, it is easy to elicit the opposite reaction due to a poor cosmetic application.
