| | GROUP<br><b>BOD</b> | MODEL<br><b>2016MY<br/>Sorento (UMa)</b> |
| | NUMBER<br><b>114 (REV 1, 09/30/2015)</b> | DATE<br><b>September 2015</b> |
| SUBJECT: SERVICE ACTION: SUNVISOR INSPECTION/REPLACEMENT<br>(SA197) | | |

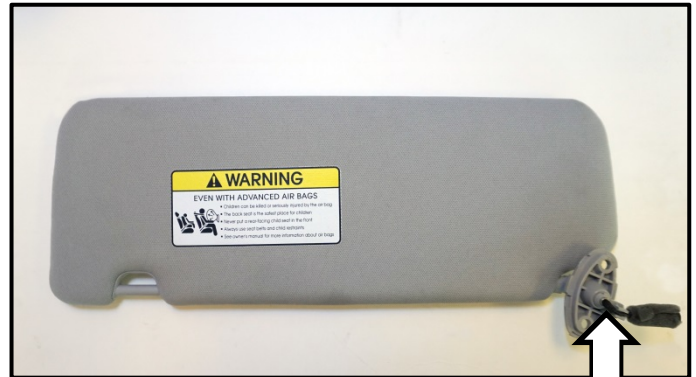
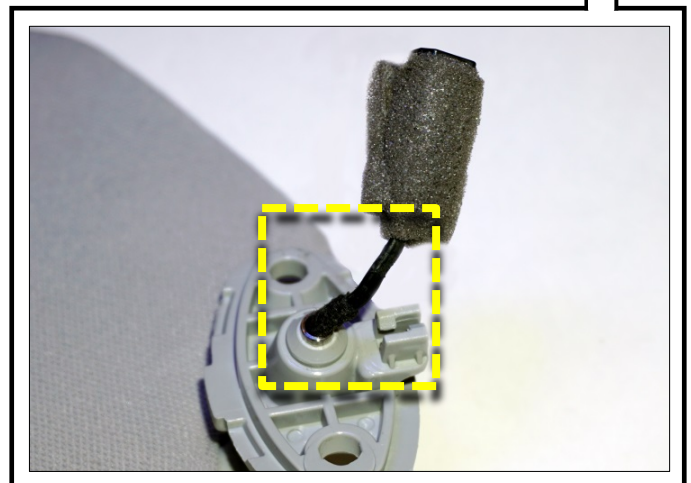
5. Place the sunvisor on a clean work surface, remove the harness from the holder and inspect it for exposed wiring. If the harness shows no visible signs of damage, proceed to step 6. If the harness shows visible signs of damage, proceed to step 7.
