SERVICE BULLETIN

APPLICABILITY: All Models with Harman Audio / Infotainment

NUMBER: 15-227-18

SUBJECT: Navigation System Functionality Concerns and
Troubleshooting

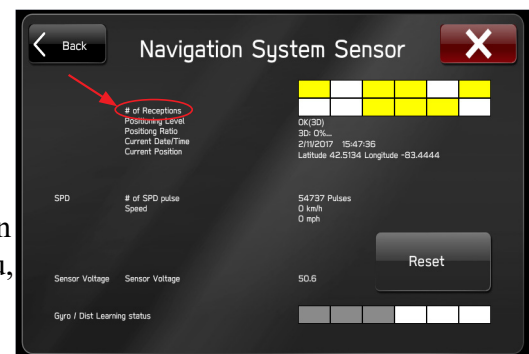
- 1) Always confirm the condition as reported by the customer.
 - a. For issues with GPS system accuracy, please follow steps (i-vii) below. If not, skip this section and move on to (b).
 - i. Can the concern be duplicated? If so, please provide the steps necessary to reproduce and if possible, a video showing the steps and concern.
 - ii. Is the concern observed in a specific location?
 - iii. If GPS accuracy is always poor regardless of route, open the Navi System Sensor screen. To access, press and hold the Home button and press the Tune knob 6 times, then release the home button. In the dealer menu, select: "Function check" > "Navi System Sensor" (See screenshot to the right).

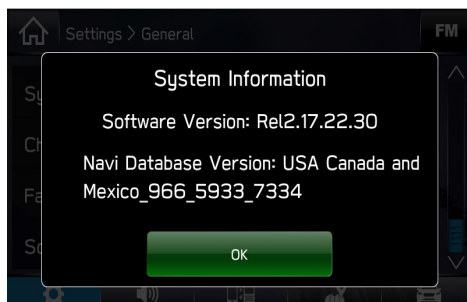
- b. For issues with **search results** or **Point of Interest (POI) list entries**, please follow (i-ii) below. If not, skip this section and move on to (c).
 - i. Can the concern be duplicated? If so, please provide steps required to reproduce it and if possible, a video showing the steps and concern. Please note the address or search result(s) for when the concern occurs.
 - ii. Please note the Software Version and the Database version. This is found under Settings > General > System Information. (See below for an example of the System Information screen with the Software and Navigation Database Version displayed.)

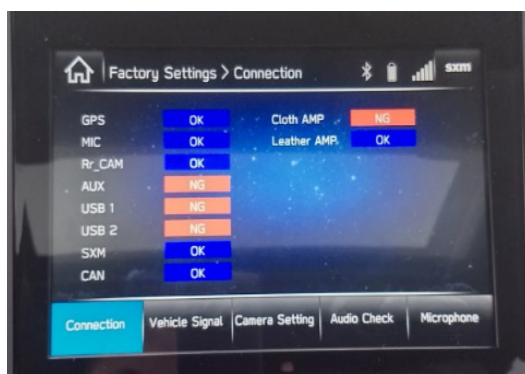
- c. For other navigation or GPS issues, please follow Service Manual procedure for basic diagnostics: **“WRONG LOCATION OF VEHICLE, NO GPS RECEPTION”**.
 - i. See the image below for Connection verification testing.
