SERVICE BULLETIN

APPLICABILITY: 2015-2018MY Legacy and Outback
 2012-2018MY Impreza
 2013-2018MY Crosstrek
 2014-2018MY Forester
 2015-2018MY WRX

NUMBER: 16-112-18R

SUBJECT: Ignition Key Sticking / Design Change to CVT
 Shifter / Selector Lever Components

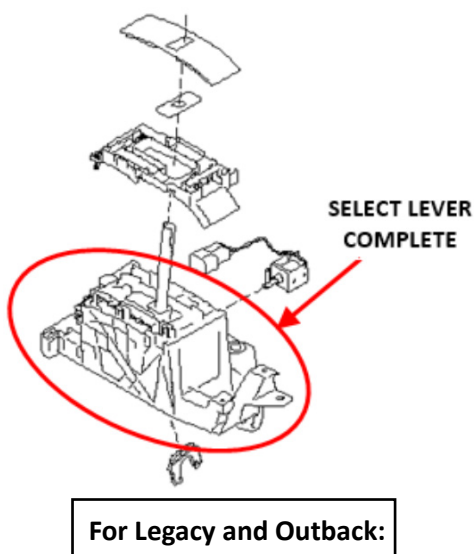
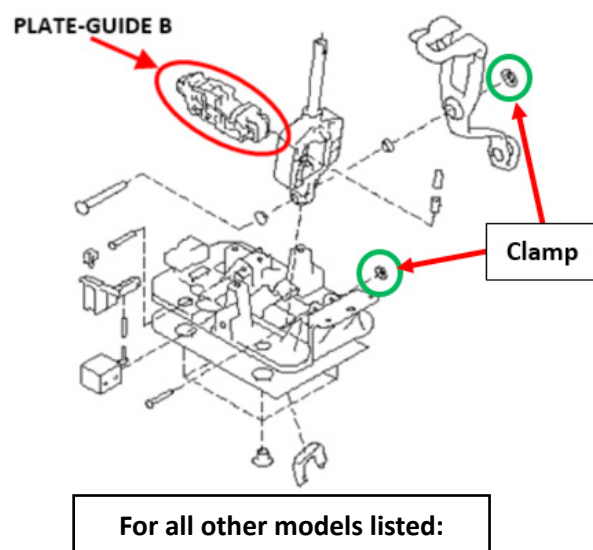
- The term PLATE-GUIDE B refers to the Park-Range switch which is a serviceable part of the select lever assembly on all models listed above **EXCEPT** Legacy and Outback. See the illustrations provided below for more details.

- For **Legacy and Outback**, the shifter assembly (SELECT LEVER COMPLETE) must be replaced if the Park-Range switch is found to be faulty.

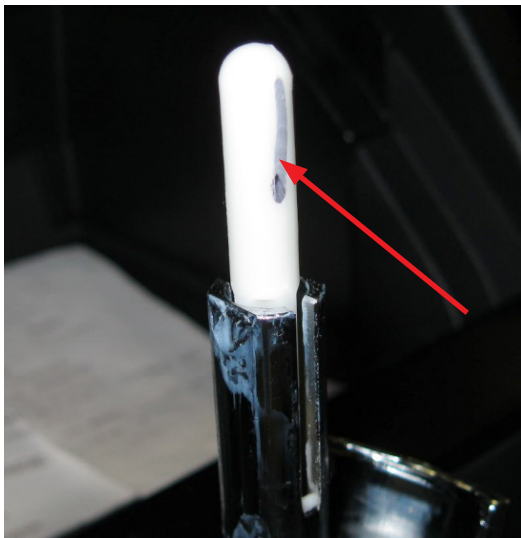
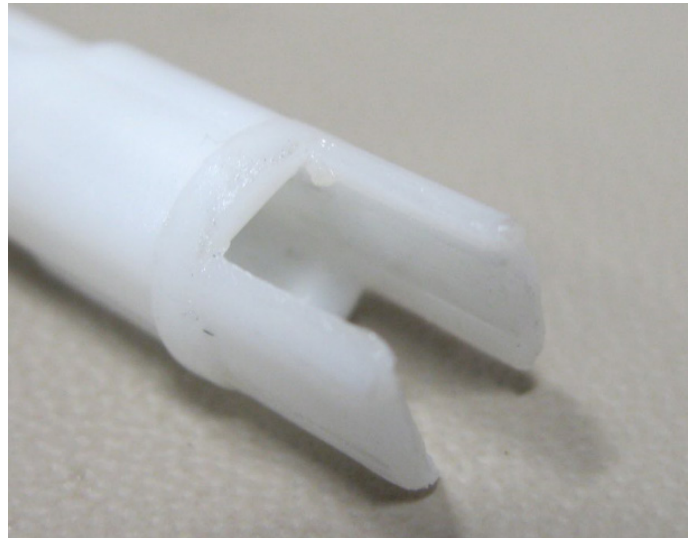
IMPORTANT TIP: After removing the shift knob there will be a white plastic rod / plunger protruding from the top of the chrome lever. Use a permanent marker and mark its position as shown in the photo so it can be put back in the same place during reassembly. The bottom end has a notch in it which must be in the correct position for proper operation of the mechanism.
