GROUP <b>Product Improvement</b>	MODEL <b>See Model List on Page 1</b>
	NUMBER <b>PI1802W/X (Rev 5, 04/10/2019)</b>	DATE <b>October 2018</b>
<b>PRODUCT IMPROVEMENT CAMPAIGN</b>		
<b>SUBJECT:</b> ENGINE REPLACEMENT INSTRUCTIONS FOR DTC P1326 (PI1802W/X)

This bulletin provides information related to the Technical Service Bulletin previously published in July 2018 ([PI1802](#), Rev 6, 01/31/2019) titled “Knock Sensor Detection System - ECU Logic Improvement”. Specifically, this bulletin provides instructions on which procedures to follow if, after installation of the KSDS, any one of the subject vehicles below returns to the dealer with Diagnostic Trouble Code (“DTC”), P1326.

Year	Model	Engine	Production Date
2014	Optima (TF)	2.4L GDI	8/29/13 – 4/25/14
2015-2018	Optima (TF/QF/JF/JFa)	2.4L & 2.0L T-GDI	4/16/14 – 7/11/18
2014-2018	Sportage (SL/QL)	2.4L & 2.0L T-GDI	9/30/13 – 4/5/18
2015-2018	Sorento (XMa/UMa)	2.4L & 2.0L T-GDI	1/3/14 – 3/7/18

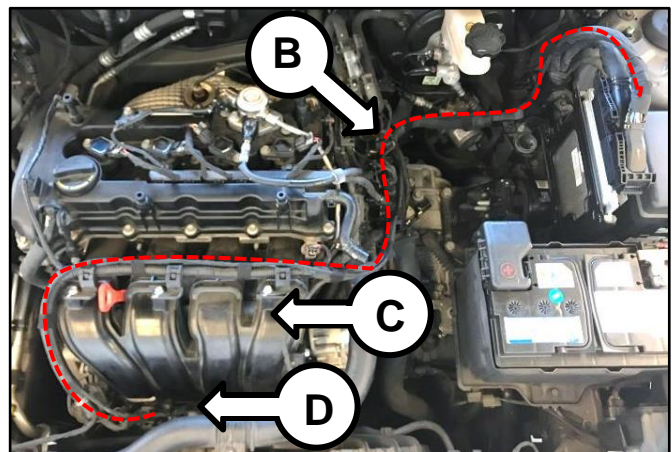
The harness (B) must be routed exactly as shown to prevent related DTCs.

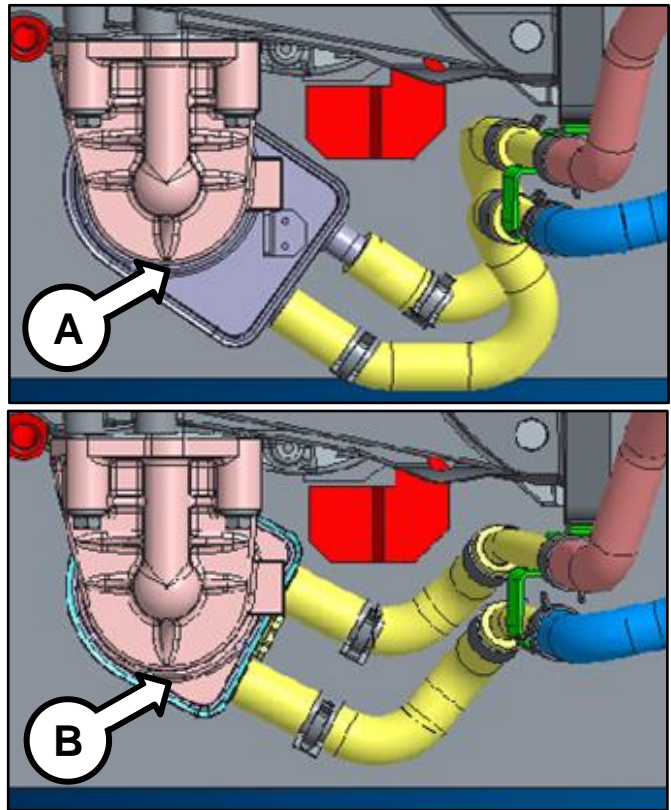
New engines may be supplied with a different oil cooler. Use steps below to determine the need for a replacement oil cooler tube assembly.

- If the new engine's (bigger) oil cooler (A) does not match the old engine's (smaller) oil cooler (B), replace the oil cooler tube assembly with the improved part. See parts table on page 24.
- If the new engine's (bigger) oil cooler (A) matches the old engine's (bigger) oil cooler (A), reuse the old engine's oil cooler tube assembly.
- If the new engine's (smaller) oil cooler (B) matches the old engine's (smaller) oil cooler (B), reuse the old engine's oil cooler tube assembly.
