Various Drivability Concerns, and/or DTCs, Corrosion Present in A43 or A9 Connector

Service Category Engine/Hybrid System

Section Engine Control

YEAR(S)	MODEL(S)	ADDITIONAL INFORMATION
2014 - 2018	Highlander, Highlander HV

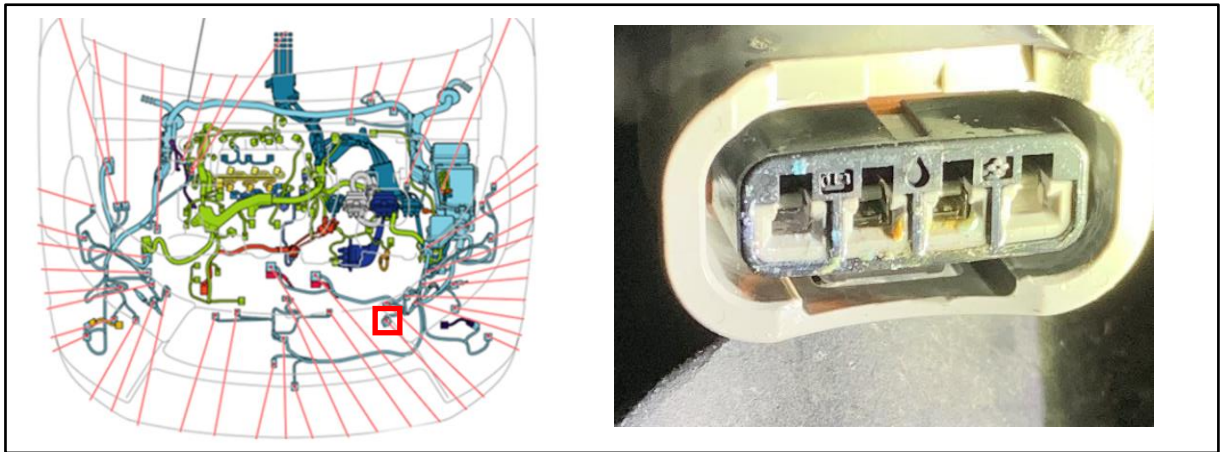
Figure 2. A9 Connector Location and Corrosion

These conditions may be caused by corrosion/water in the A43 ECM connector (Highlander) or the A9 inverter water pump connector (Highlander HV). The corrosion in the A43 and A9 connectors is due to poorly sealed or damaged aftermarket windshield deicer harnesses. Follow the Repair Procedure in this bulletin to address these conditions.

4. Remove the A9 inverter water pump with motor assembly connector.

Is corrosion or water present?

6. Replace the components listed in the table below.

NON-HYBRID VEHICLE	HYBRID VEHICLE
COMPONENT	ECM	Inverter Water Pump
	Engine Room Main Wire Harness	Engine Room Main Wire Harness
	Windshield	Windshield

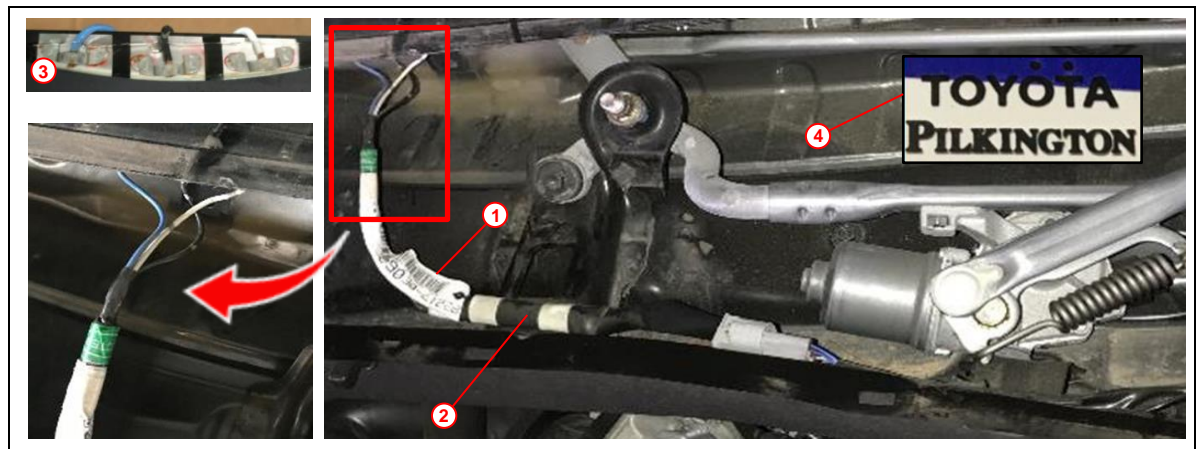
Figure 4.

It is strongly recommended to replace the windshield with a Toyota genuine windshield. Toyota windshields utilize special seals to prevent water/moisture from entering the engine room main wire harness. Some aftermarket windshields do NOT have these seals.
