## SERVICE INFORMATION BULLETIN

**APPLICABILITY:** 2015-19MY Legacy and Outback  
2017-18MY Forester  
2017-20MY Impreza  
2018-20MY Crosstrek  
2015-20MY WRX  
2017-20MY BRZ

**NUMBER:** 07-171-20

**SUBJECT:** Battery Sensor Removal and Installation Precautions

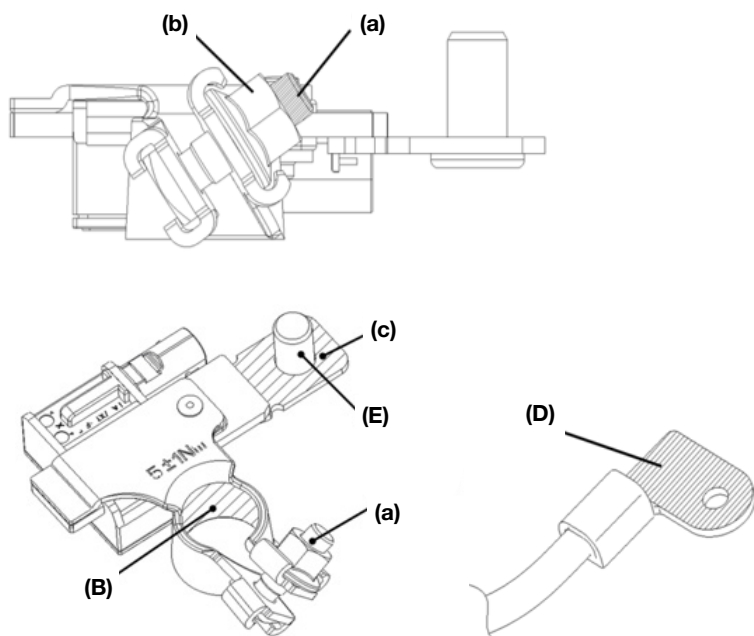
### LEGACY/OUTBACK/FORESTER/WRX/ BRZ

This Service Information Bulletin is in response to several battery sensor replacements resulting from improper removal and / or installation practices. Some common mistakes related to battery sensor removal and / or installation are:

- Disconnect the sensor harness connector.
- While supporting and holding the sensor in place with one hand, remove the 12 mm hex nut from (c) and disconnect the ground cable (D) from the sensor stud (E). Loosen but **DO NOT REMOVE** the 10 mm hex nut from the clamping bolt. **REMINDER:** The threaded end of the clamp bolt (a) is crimped. If the 10 mm nut (b) is loosened too far, the threads of both the nut and bolt can become damaged and the clamp portion distorted.
- **CAREFULLY** clean any grease from the battery post, inside the clamping portion (B) and the ground cable connection (C) using a mild solvent on a clean shop cloth.
