# TECHNICAL SERVICE BULLETIN

| BT22-023 | NTB22-104 | December 12, 2022 |

## DIAGNOSING DOOR LOCK OPERATION

- APPLIED VEHICLES:** 2021-2023 Altima (L34)  
2022-2023 Frontier (D41)  
2022-2023 Pathfinder (R53)  
2021-2023 Rogue (T33)  
2021-2022 Sentra (B18)
- APPLIED DATES:** 2021 Altima built after April 2021  
2022-2023 Altima All  
2022-2023 Frontier All  
2022-2023 Pathfinder All  
2021 Rogue built after June 2021  
2022-2023 Rogue All  
2021 Sentra built after January 2021  
2022 Sentra All

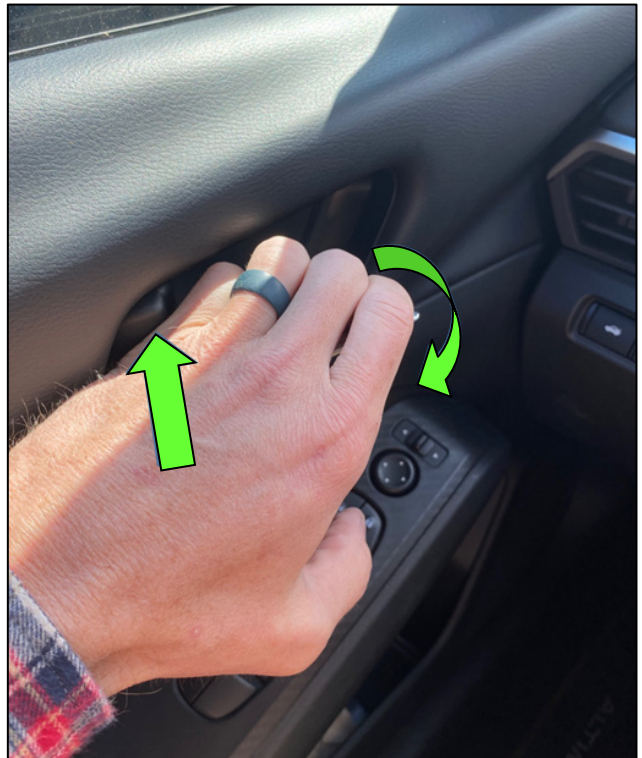
Figure 1

- If the Inside Lock Knob is positioned somewhere between fully locked and fully unlocked, it can result in the door becoming stuck in the half-lock position, and cause the power lock to be unresponsive.

- o This can be caused by contact with the Inside Lock Knob as the Inside Handle is actuated to open the door from inside the vehicle and is not a defect. Do not replace the Door Lock as it can happen just as easily with the replacement Door Lock.

- o Demonstrate to the customer what is believed to be causing their concern.
      - a. Show that it is possible to inadvertently move the Inside Lock Knob with the heel of your hand when pulling the Inside Handle to exit the vehicle.

- b. If the concern happens again, ask the customer to confirm if the Inside Lock Knob is partially or fully locked. The concern should be resolved by manually unlocking the door with the Inside Lock Knob.
  - If this concern is confirmed, a slightly altered approach to opening the door can be used to avoid inadvertent contact with the Inside Lock Knob.
- c. If the issue persists and it is confirmed that the Inside Lock Knob was not moved, proceed to step 4.
