May 26, 2016

SUBJECT: Safety Recall 09S09 – Supplement #1 Certain 1992-2003 Model Year Vehicle Lines Speed Control System Modification

CERTAIN 1992 - 2003 MODEL YEAR VEHICLE LINES -SPEED CONTROL SYSTEM MODIFICATION

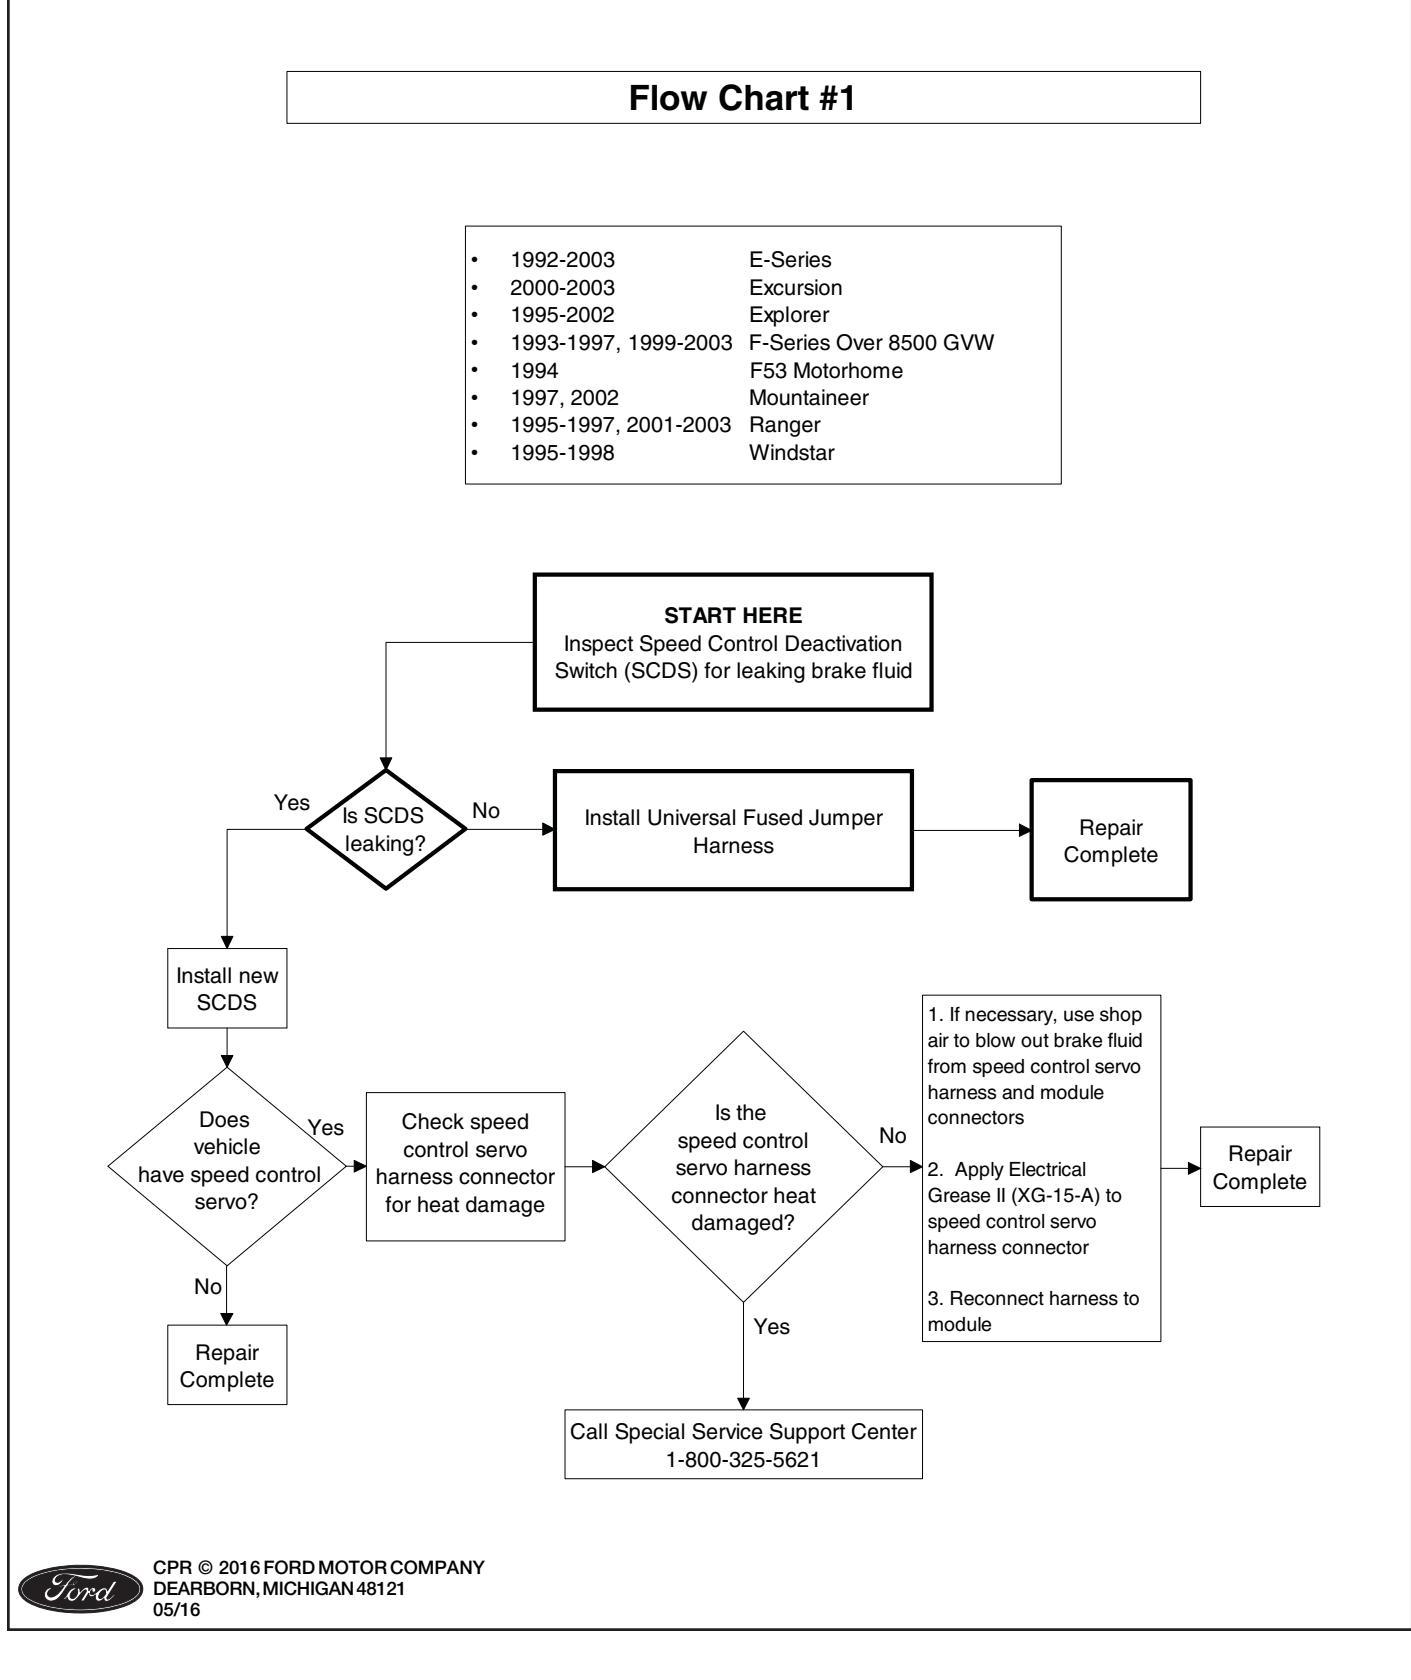
This Safety Recall involves an inspection of the Speed Control Deactivation Switch (SCDS) harness connector for the presence of brake fluid contamination. If no brake fluid is present, install the universal fused jumper harness. If brake fluid is present, replace the SCDS and inspect the speed control servo harness connector for heat damage. See Flow Chart#2 on page 3.

Flow Chart #1 shows the repair procedure for all affected vehicles except 1999 through 2003 Windstar vehicles.

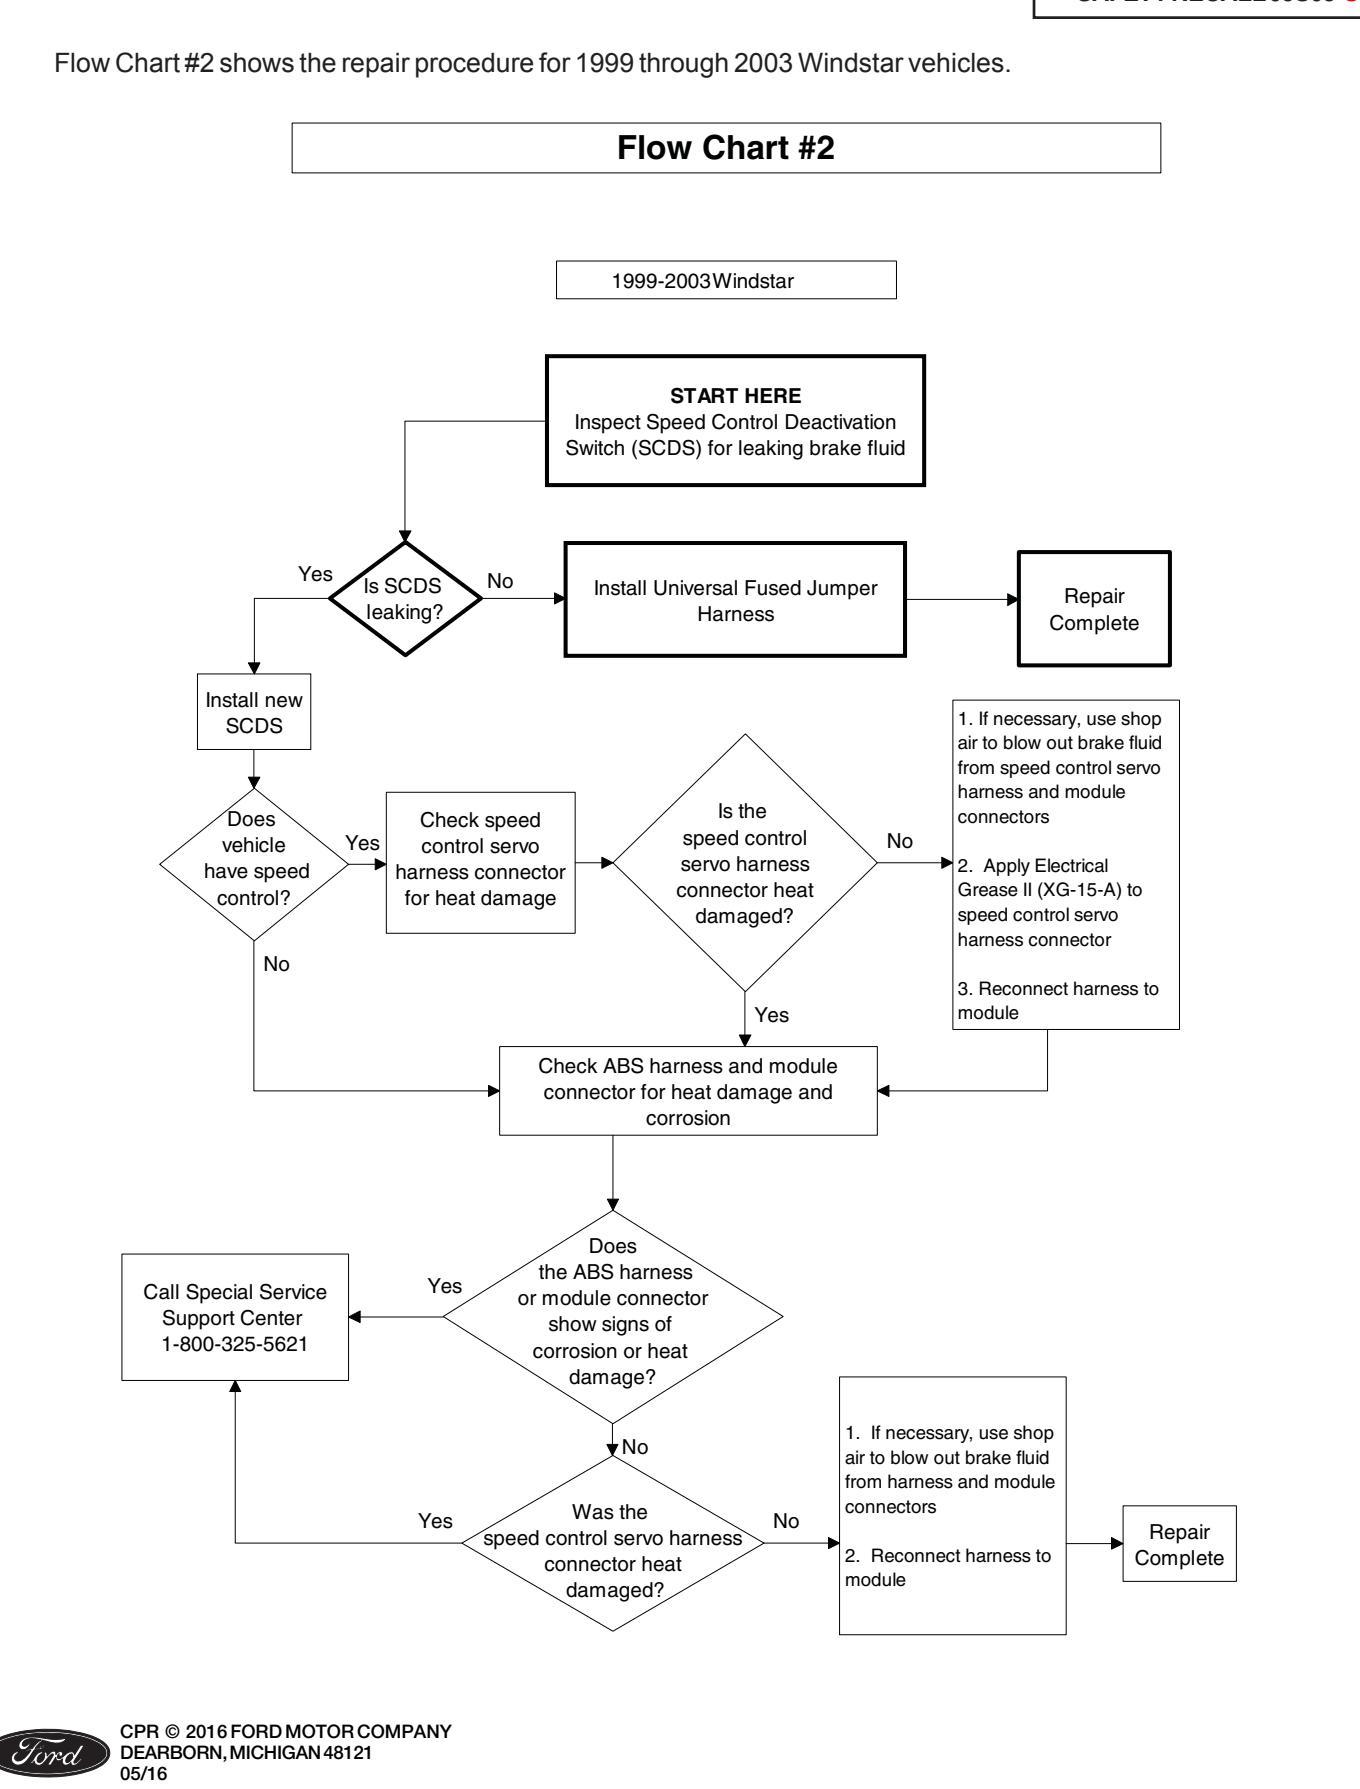
In addition, for 1999 through 2003 Windstar vehicles, the repair includes an inspection of the Anti-lock Brake System (ABS) connectors. See Flow Chart #2 on page 3.

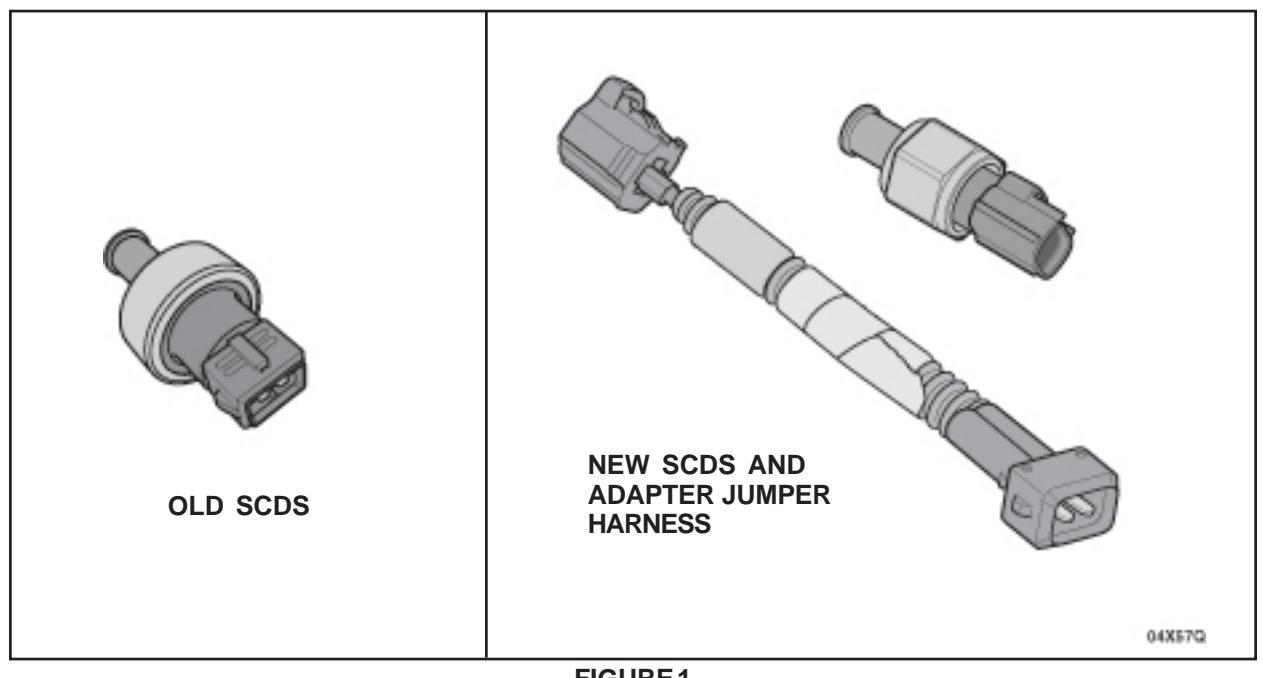
FIGURE 1

The Speed Control Deactivation Switch (SCDS) involved in Safety Recall 09S09 and the revised SCDS are illustrated below (See Figure 1).

Note that the revised SCDS has a different electrical connector. An adapter jumper harness (which is included in the parts kit) is required when replacing the old SCDS with the revised SCDS.

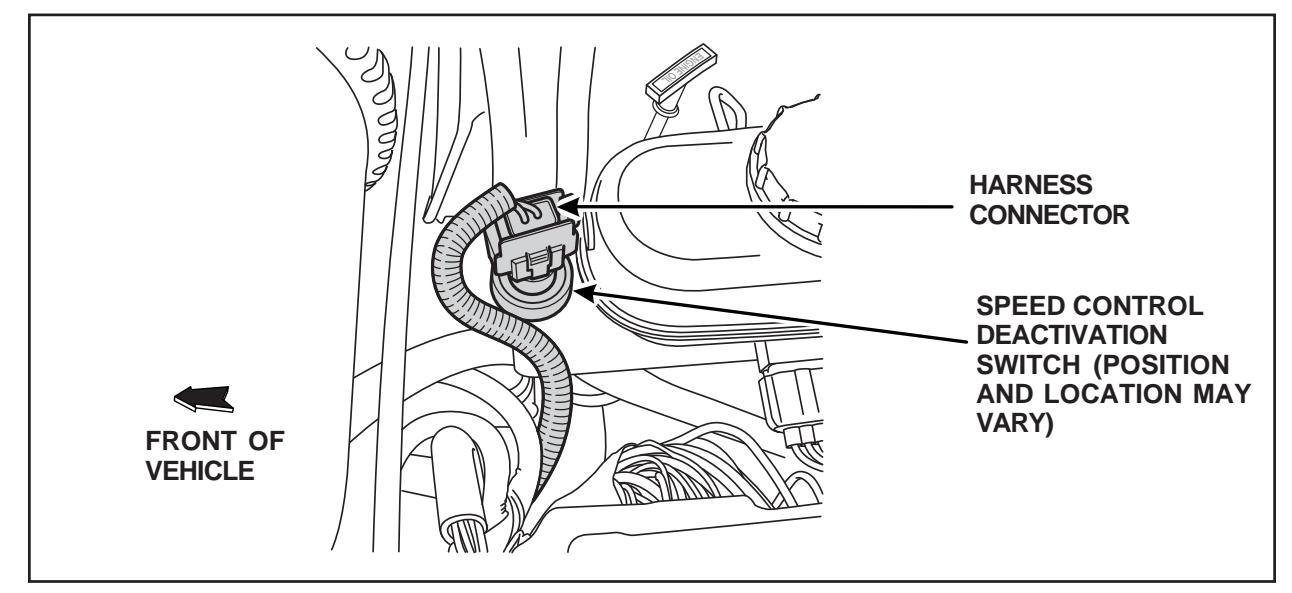
FIGURE 2

- **NOTE:** For E-Series vehicles, there is a possibility that the vehicle was manufactured without a SCDS. If unable to locate a SCDS after checking on all the brake lines, no further action is required, release the vehicle.
- **NOTE:** On 1992-1993 E-Series and 1993 F-Series vehicles, it may be necessary to lift the vehicle to gain access to the SCDS. On Windstar vehicles, the air cleaner housing must be separated in the middle to gain access to the SCDS.
 - 1. Disconnect the harness connector from the SCDS (See Figure 2).

- 2. Inspect the harness connector for the presence of brake fluid.
 - If there is **no** evidence of brake fluid on the connector, install Universal Fused Jumper Harness (UFJH). See page 6.
 - If there is evidence of brake fluid on the connector, replace SCDS. See page 7.

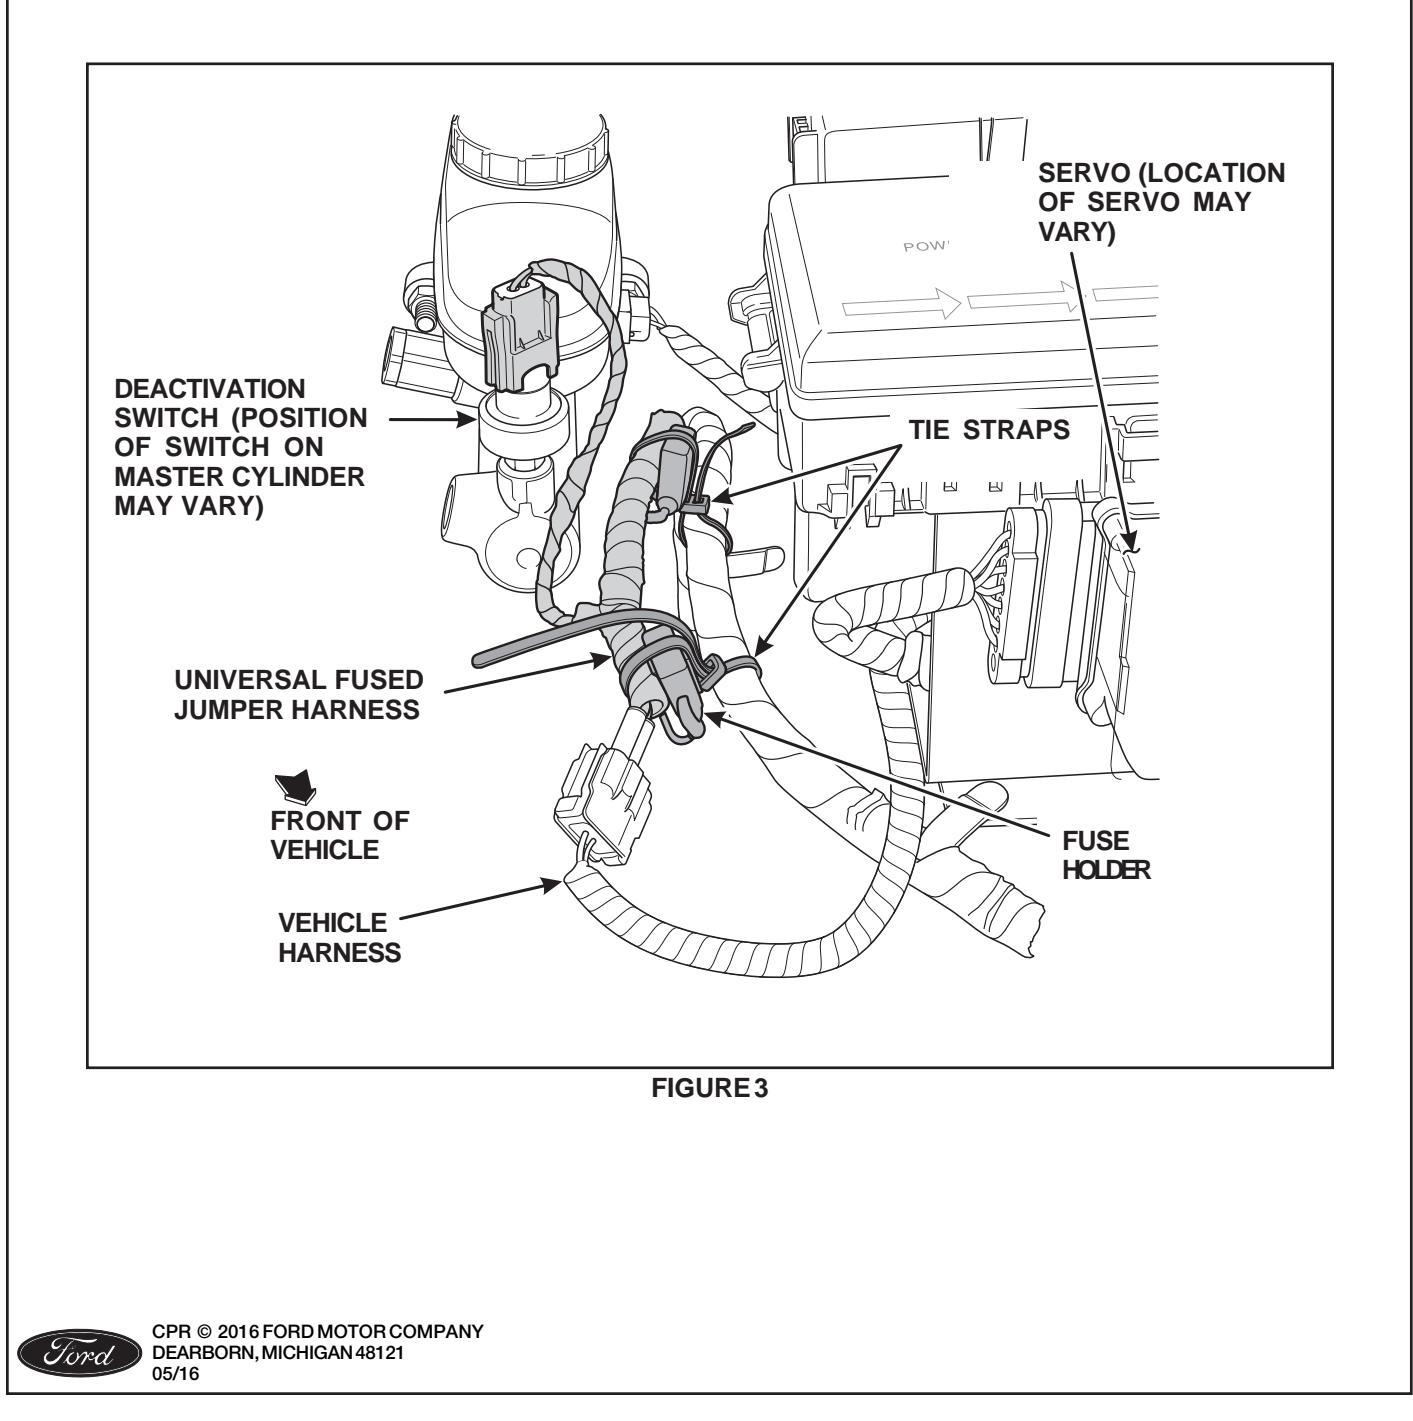
- 1. Connect the Universal Fused Jumper Harness (UFJH) to the SCDS and the vehicle harness.
- 2. Secure the UFJH to the existing harness with tie straps, making sure the fuse holders are positioned vertically with the fuse holder cap facing upward. Wrap the tie straps underneath, then over the top of the existing harness and verify proper fuse holder orientation (See Figure 3).
- 3. No further action is required, release the vehicle.

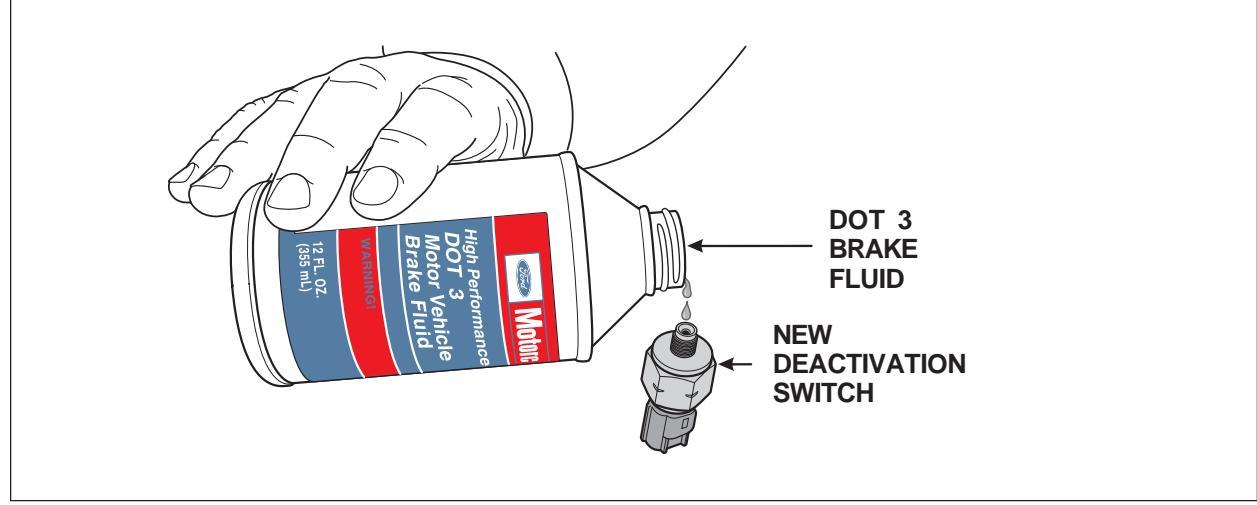
FIGURE 4

- 1. Check the brake fluid level at the master cylinder and, if necessary, fill to maximum fluid level.
- NOTICE: DO NOT apply fluid to the electrical connector or damage to the connector may occur.
 - Add a few drops of Motorcraft High Performance DOT 3 Motor Vehicle Brake Fluid, PM-1-C (US), CPM-1-C (Canada), to the fluid port at the threaded end of the *new* SCDS (See Figure 4).

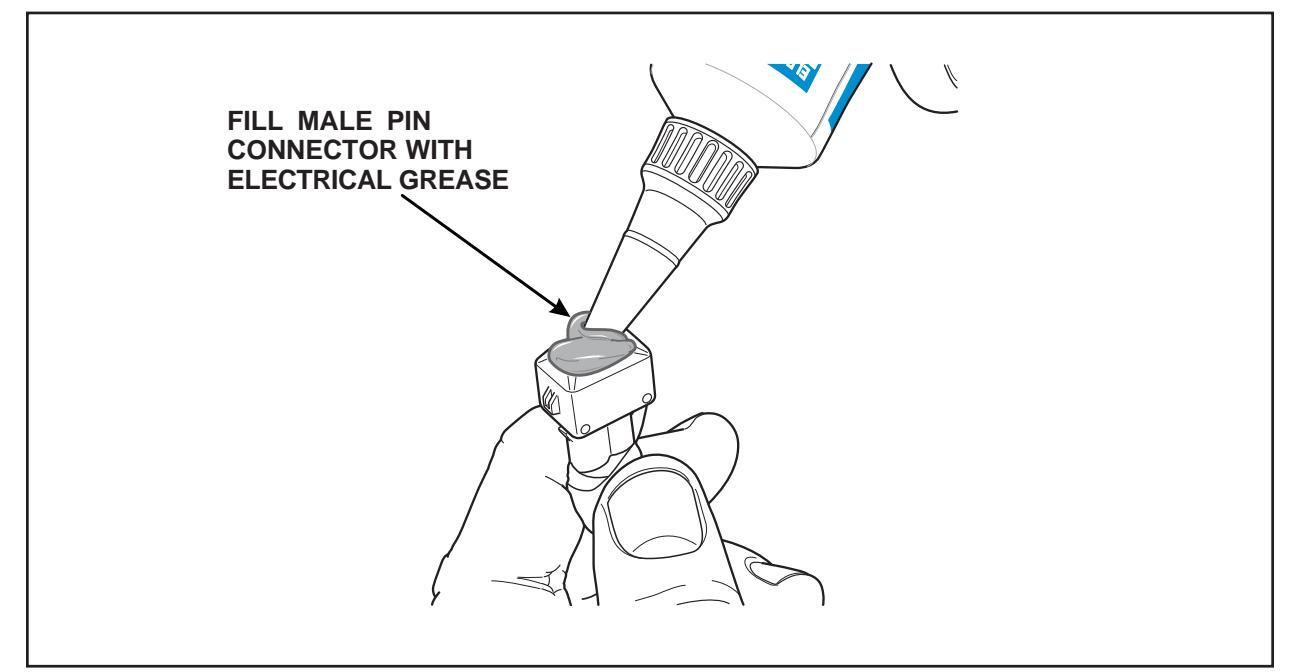
FIGURE 5

- 5. Check the brake fluid level at the master cylinder, fill to maximum fluid level and install the brake fluid reservoir cap.
- 6. Before installing the adapter jumper harness, fill the vehicle harness end of the jumper (male pin connector end) with **Motorcraft Electrical Grease II (XG-15-A)** (See Figure 5).

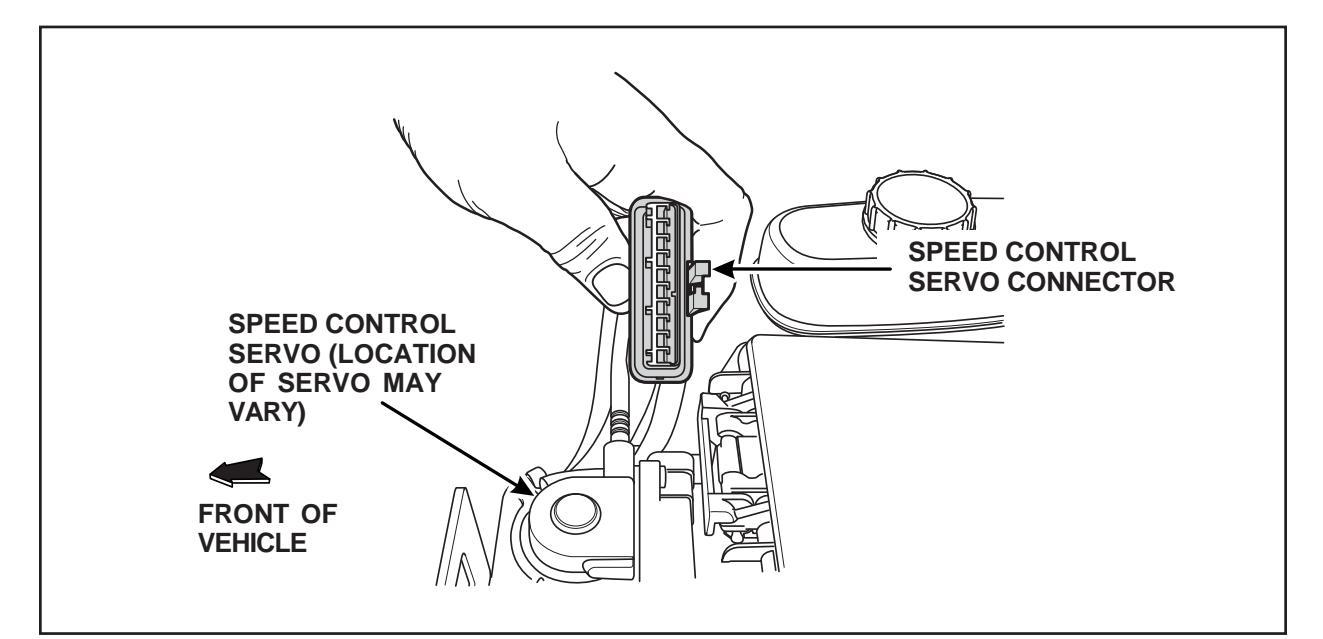
FIGURE 6

- 1. Disconnect the speed control servo and inspect the vehicle harness connector for heat damage (See Figure 6).
 - If no heat damage is found at the speed control servo connector (even if there is presence of brake fluid in the connector), proceed to step 2 for further instructions.
 - If heat damage is found, proceed as follows:
 - 1999-2003 Windstar, complete ABS inspection on page 11 before calling the Special Service Support Center for further instructions.
 - All other vehicles, call the Special Service Support Center for further instructions.

- 2. With the speed control servo disconnected, use shop air to blow out any trace of brake fluid from the speed control servo harness electrical connector and the servo module. **Do not use any type of solvent to clean the connectors.**
- 3. Apply a 5 mm (3/16 in) high bead of **Motorcraft Electrical Grease II (XG-15-A)** across the entire width and length of the servo vehicle harness connector (See Figure 7).
- NOTICE: Be sure to apply an adequate amount of grease to the vehicle harness connector only. DO NOT apply the grease directly to the connector of the servo module.

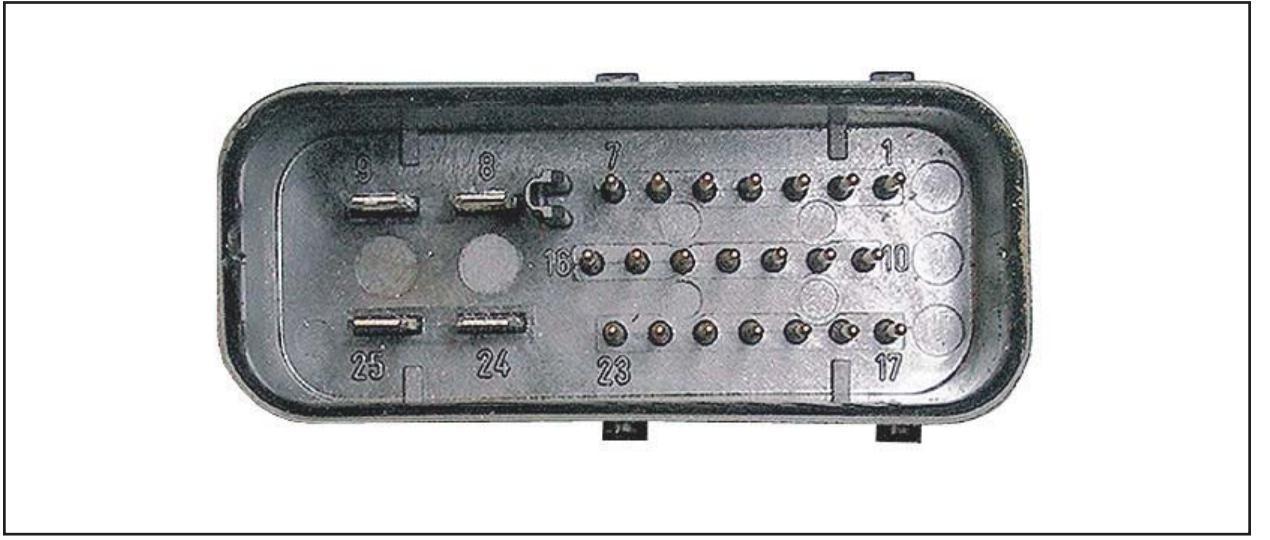
- 1. Lift vehicle and remove ABS cover.
- 2. Disconnect ABS module. Inspect the ABS harness and module connectors for the presence of brake fluid.
- 3. If brake fluid is present, use shop air to blow out any trace of brake fluid from the harness connector and module.
- 4. Inspect the ABS harness and module connectors for corrosion and/or heat damage (See Figure 8).

- FIGURE 8
- 5. If evidence of corrosion and/or heat damage is found in either the ABS harness or module connector, call the Special Service Support Center for further instructions.
- 6. If there is no evidence of corrosion and/or heat damage, reconnect the ABS harness to the ABS module.
- 7. Is the speed control servo heat damaged?
 - If the speed control servo **is** heat damaged, call the Special Service Support Center for further instructions.
 - If the speed control servo **is not** heat damaged, no further action is required, release the vehicle.
