Product Safety Recall

N212328800 Front Passenger Airbag Takata Inflator

- Priority Group 10

Revision: 02

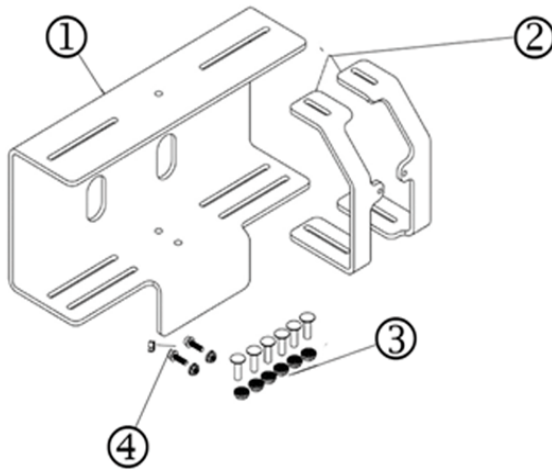
4006668

(1) Mounting Bracket (2) Support Bars (3) Support Bar Hardware (4) Airbag Mounting Hardware.

Dealers must use the airbag mounting bracket, shown below, to replace the front passenger airbag inflator. As of December 31, 2015, all U.S. dealers have been shipped the airbag mounting bracket at no charge through Bosch Automotive Service Solutions. The Bosch tool number is EL-51377. If your dealership does not have the airbag mounting bracket, do not attempt to perform this service procedure and immediately contact **1-800-GM-TOOLS** for assistance. Attempting to replace the front passenger airbag inflator without using the bracket may pose a safety risk for the technician and anyone else in the area.

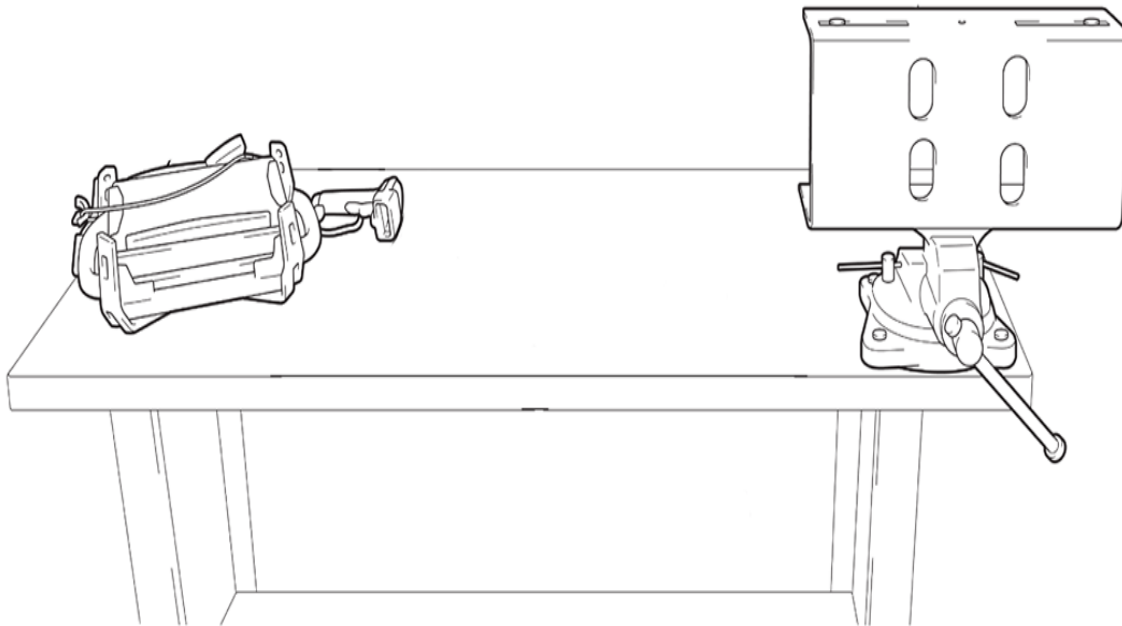
3607819

Danger: To avoid personal injury or death, it is critical to use an airbag module bracket when replacing an inflator module. Carefully read and follow the instructions below:

1. Confirm the bracket assembly is installed securely in the vise.
2. Confirm there are no loose objects or people exposed to the back side of the bracket for safety in the unlikely event of airbag deployment due to improper work procedures. The airbag is NOT being replaced due to an inadvertent deployment concern.
3. Confirm that no objects, tools or people are within 3 feet (1 meter) of the back side of the bracket.
4. Confirm that no objects, tools or people are within 2 feet (0.6 meters) of the sides of the bracket.
5. BEFORE starting work and periodically while working on the airbag module, touch a metallic part of the work bench to discharge static electricity in the body.
