## SERVICE BULLETIN

**APPLICABILITY:** 2015-2017MY WRX and STI Models

**NUMBER:** 07-111-16

**SUBJECT:** Headlamps- Design Change to Prevent  
Moisture Intrusion

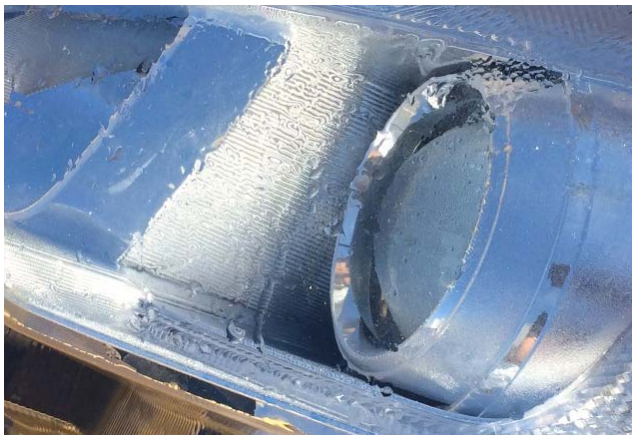
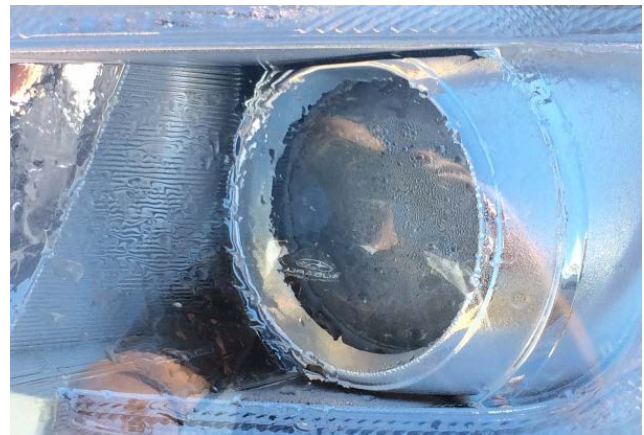
This bulletin announces a design change to the headlamp assembly to improve sealing and prevent moisture intrusion. This condition may result from a slight misalignment of the attaching points during the headlamp assembly process. An improved sealing material is now being used for bonding the outer lens to the housing.

The new headlamp assemblies were incorporated into production starting with **VIN H\*800014**, at the **end of March, 2016**.

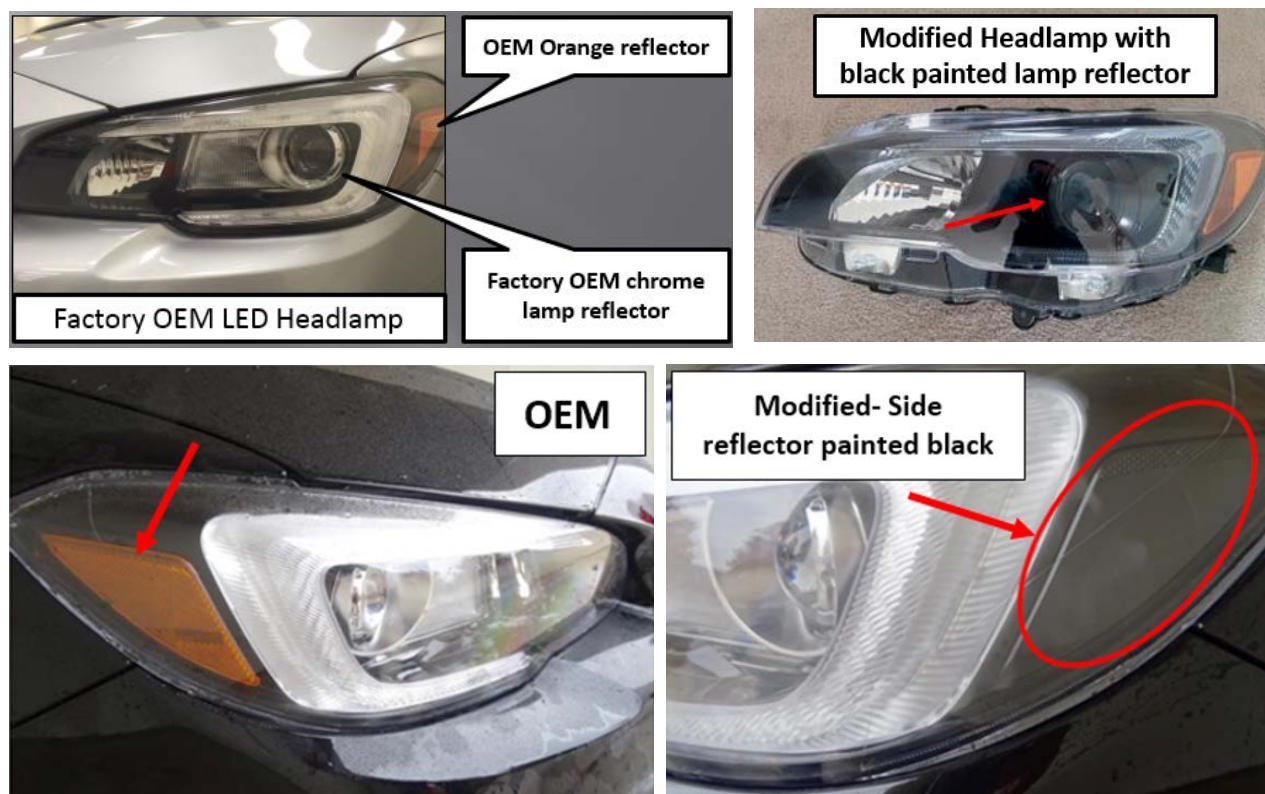
Inspect the headlamp assemblies closely to confirm they have not been modified and that they are Genuine Subaru (OEM) parts and not aftermarket replacement units. Photos comparing the OEM part to examples of modified headlamps are provided below. Modified headlamps are not warrantable.

Whenever replacing a headlamp assembly, always follow all the procedures in the applicable Service Manual. In addition, pay close attention to the front bumper fascia R&R along with the headlamp and fog lamp aiming procedures (where required). Replace only the affected headlamp assembly if this concern is duplicated.
