HVAC Evaporator Drain Hose Clogged Due to Insect Intrusion

Service Category Vehicle Interior

Section Heating/Air Conditioning

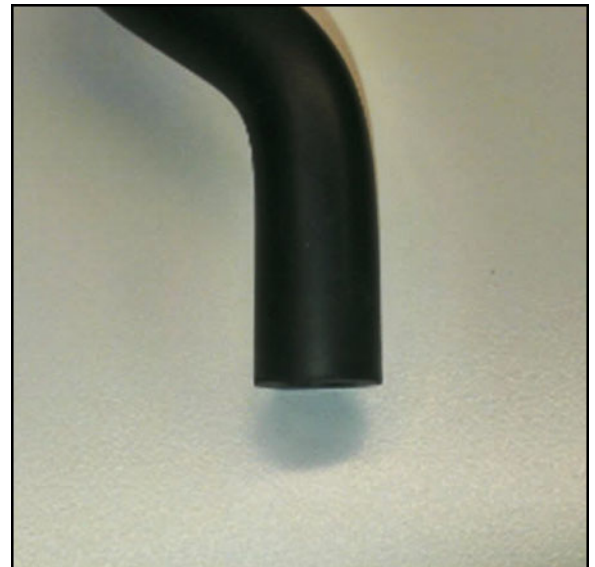
1. Follow the instructions provided in the Safety Requirements for Handling the ARINIX® Tip (Connector, Water Hose) section of this bulletin.
2. Locate the HVAC Evaporator Drain Hose.
3. Following the vehicle specific Repair Manual, remove the HVAC Evaporator Drain Hose.
4. Before installing the ARINIX® Tip (Connector, Water Hose) into the NEW HVAC Evaporator Drain Hose, the end of the hose needs to be cut perpendicular as shown in Figure 2.

1. Follow the instructions provided in the Safety Requirements for Handling the ARINIX[®] Tip (Connector, Water Hose) section of this bulletin.
2. Locate the HVAC Evaporator Drain Hose
3. Following the vehicle specific Repair Manual, remove the HVAC Evaporator Drain Hose.
4. Before installing the ARINIX[®] Tip (Connector, Water Hose) into the original HVAC Evaporator Drain Hose, the end of the hose needs to be cut perpendicular as shown in Figure 2.
5. Put on all necessary PPE and install the ARINIX[®] Tip into the original HVAC Evaporator Drain Hose listed in the Parts Information section of this bulletin.
6. When installing the ARINIX[®] Tip, verify it is fully seated in the HVAC Evaporator Drain Hose as shown in Figure 1.
7. Following the vehicle specific Repair Manual, install the HVAC Evaporator Drain Hose.
