# Power Back Door Squeak Noise

Some 2014 – 2018 model year Highlander and Highlander HV vehicles may exhibit a condition where the power back door (PBD) makes a squeak noise while the door is opening or closing. Follow the Repair Procedure in this bulletin to address this condition.

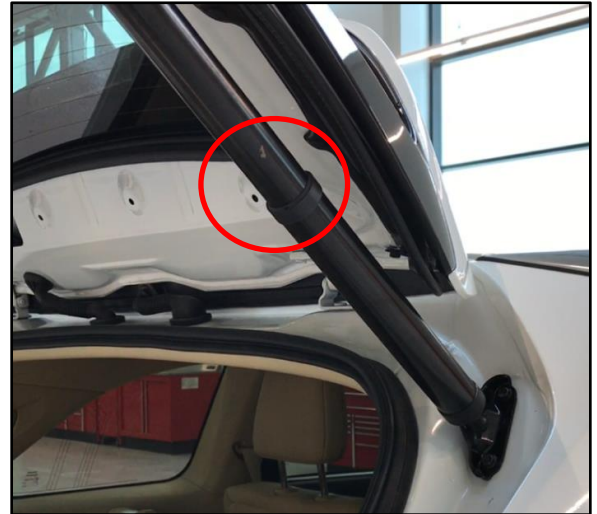
Figure 1.

1. Confirm the squeak noise location.

Is the squeak noise coming from the seal in the strut of the PBD unit assembly?

3. Replace both the RH and LH PBD unit assembly.
