GROUP Product Improvement	MODEL See Model List on Page 1
	NUMBER PI1802Y/Z	DATE March 2020
PRODUCT IMPROVEMENT CAMPAIGN		
SUBJECT: ENGINE REPLACEMENT INSTRUCTIONS FOR DTC P1326 (PI1802Y/Z)

This bulletin provides information related to the Technical Service Bulletin previously published in July 2018 (PI1802 Rev 10, 03/16/2020) titled "Knock Sensor Detection System - ECU Logic Improvement". Specifically, this bulletin provides instructions on which procedures to follow if, after installation of the KSDS, any one of the subject vehicles below return to the dealer with Diagnostic Trouble Code (DTC) P1326 (Knock Signal Range/Performance).

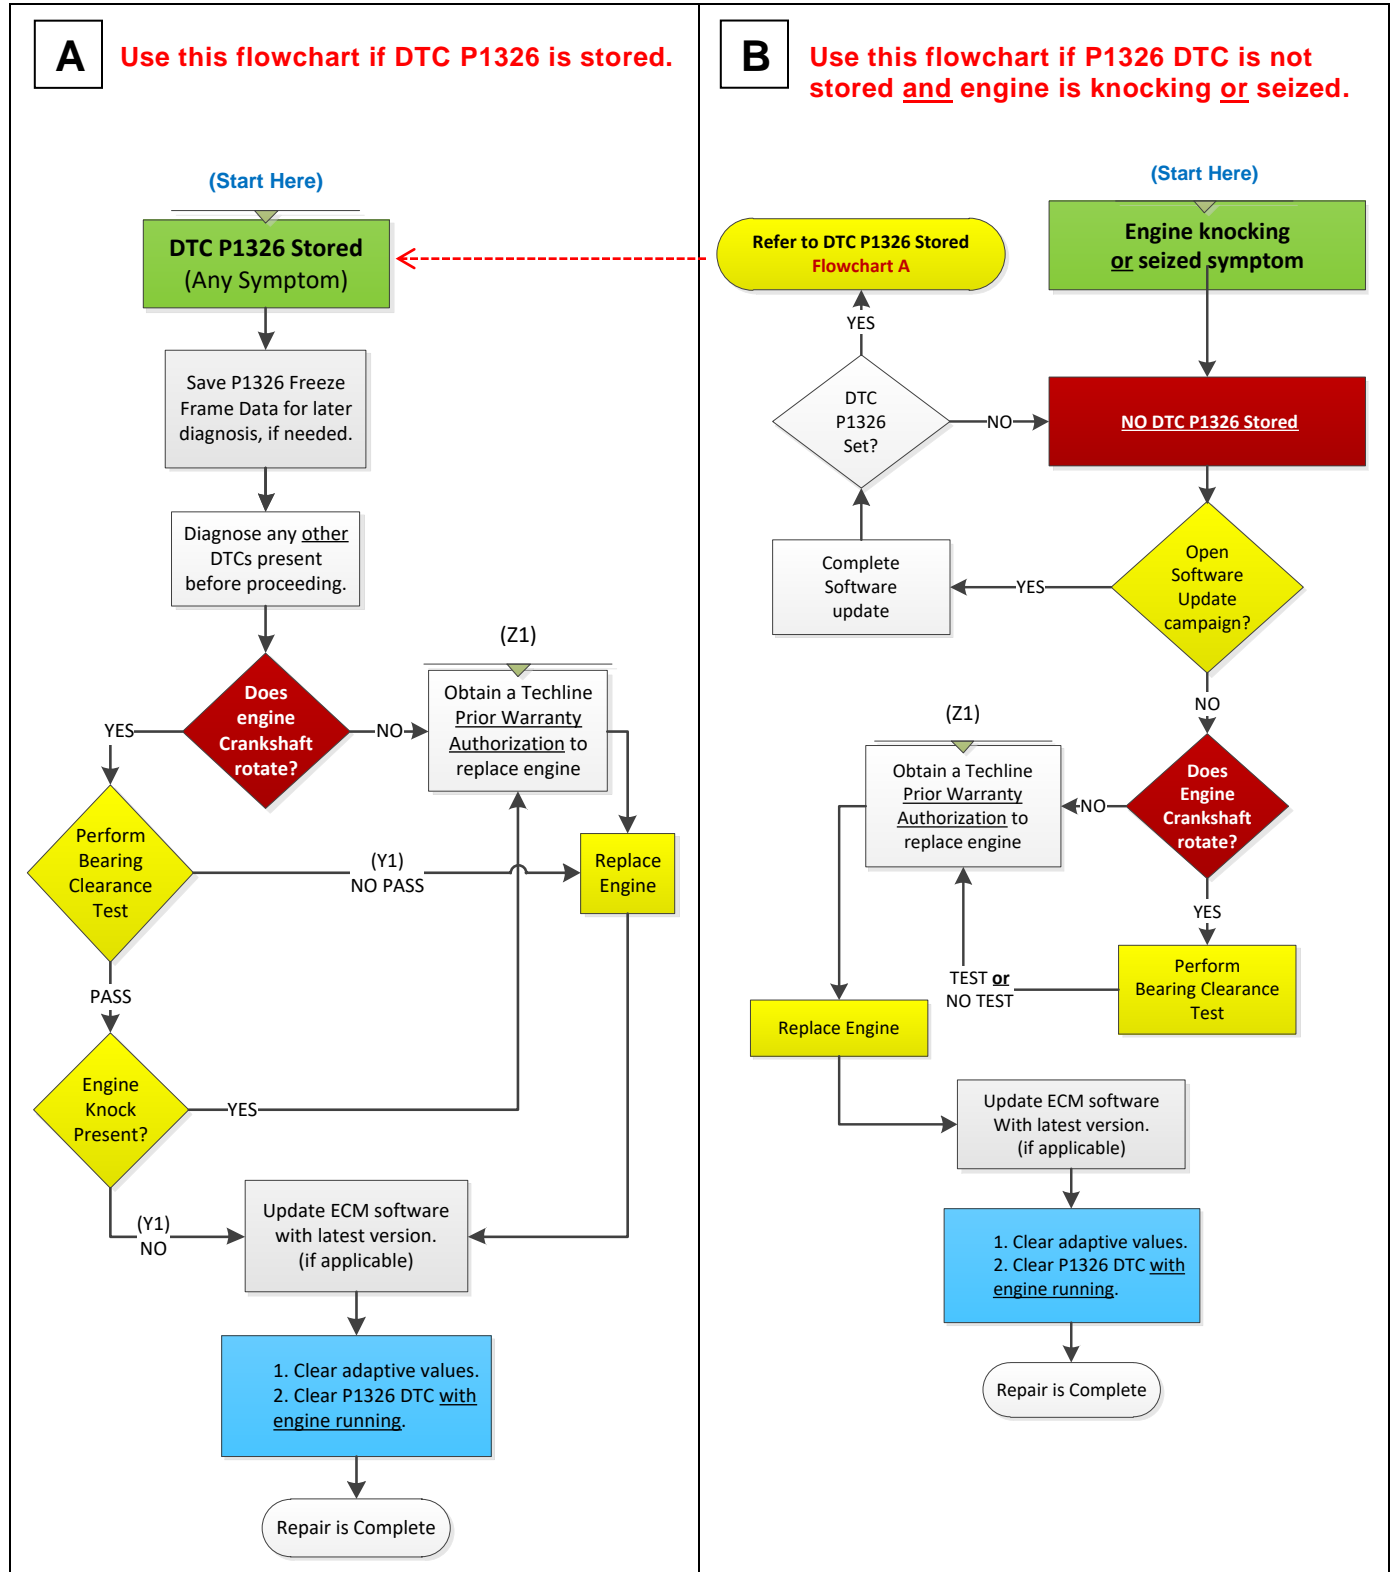
SUBJECT: ENGINE REPLACEMENT INSTRUCTIONS FOR DTC P1326 (PI1802Y/Z)
Flowcharts:

Choose the applicable flowchart based on the initial inspection:

- **Scenario 1** – Vehicle is in with DTC P1326 stored (A).
- **Scenario 2** – Vehicles is in with no DTC P1326 stored but engine is knocking or seized (B).
- **Scenario 3** – Vehicle is in with DTC P1326 stored and also engine is making noise or seized (A).

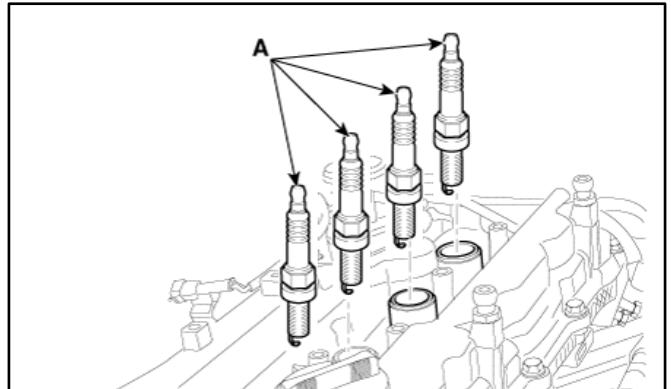
2. Remove the four (4) spark plugs (A) by referring to the "Maintenance → Power Train → Spark Plug → Repair procedures (Replacement)" in the applicable Shop Manual on KGIS.

Tightening torque for Spark Plugs:
10.9 – 18.0 lb.ft (14.7 – 24.5 N.m,
1.5 – 2.5 kgf.m)

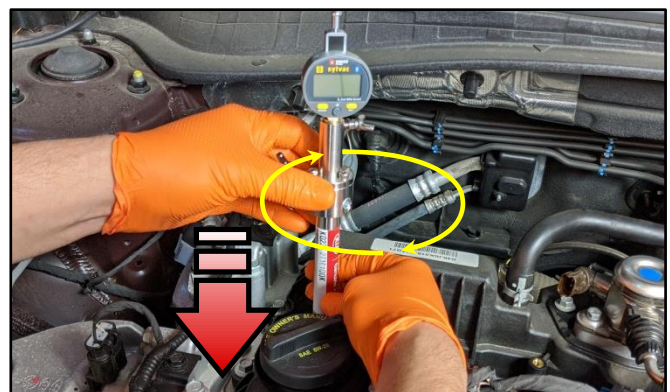
8. **Carefully**, insert the assembled SST Probe Rod and Dial Gauge into the Cylinder 1 spark plug hole and **carefully** turn the SST Crankshaft Rotator **by hand** clockwise until hand tight.

Damage to cylinder head can occur if spark plug hole is cross-threaded. DO NOT use a wrench to tighten the SST rod.

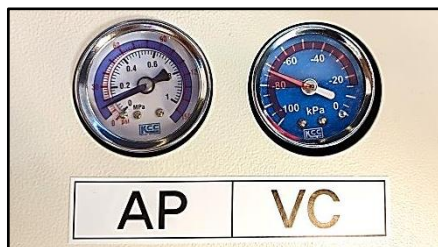
18. Turn the Bearing Clearance Tester power switch to the 'ON' position. Gauges should read as follow:

AP (Pressure) Gauge: (0.1 ~ .011MPa)
VC (Vacuum) Gauge: (-73 ~ -83kPa)

If the gauges do not read within specification, calibration of the SST box is required. Refer to [TSB SST067](#) for details.

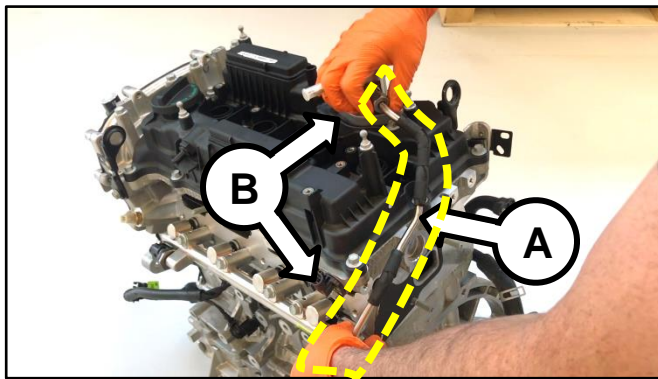
1. Properly position the new fuel pipe (A) and then hand-tighten both flare nuts (B).

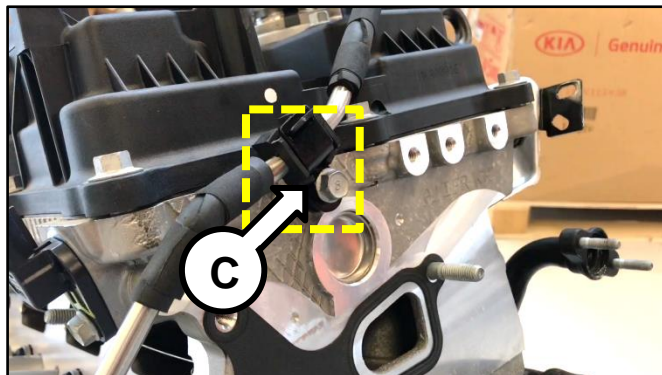
2. Install the pipe retaining bracket and bolt (C) and torque to specifications.

**Tightening torque (bracket bolt):**

5.8 – 8.7 lb.ft (7.8 – 11.8 N.m,
0.8 – 1.2 kgf.m)

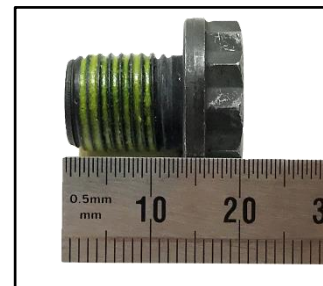
Drive Plate Bolt (A/T)

- Replace all seven (7) drive plate (AT) bolts.

**86.8 – 93.9 lb.ft (117.7 – 125.5 N.m,
12.0 – 13.0 kgf.m)**
