SERVICE BULLETIN

APPLICABILITY: 2015-20MY WRX and WRX STI

NUMBER: 12-305-20

SUBJECT: Front Hood Intake Duct- Design Change

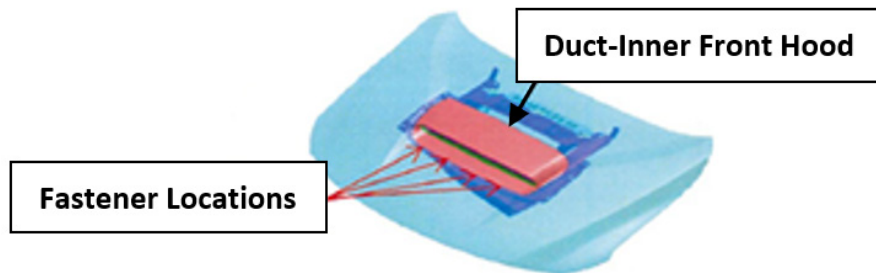
This bulletin announces a design change made to the front hood air intake duct used on the models listed above. The new duct utilizes larger holes at the attachment points to facilitate the use of mounting bolts with a larger shoulder (boss) diameter as shown (in green) in the illustrations below. For this reason, the new mounting bolts are not interchangeable and cannot be used with the original style duct.

The new duct and mounting bolts were incorporated into production starting with VIN **L9819487**.

- New Mounting Bolt: **901020030**
- New Duct-Inner Front Hood: **57253VA011**
