GROUP <b>Product Improvement</b>	MODEL <b>See Model List on Page 1</b>
	NUMBER <b>PI1802W/X (Rev 5, 04/10/2019)</b>	DATE <b>October 2018</b>
<b>PRODUCT IMPROVEMENT CAMPAIGN</b>		
<b>SUBJECT:</b> ENGINE REPLACEMENT INSTRUCTIONS FOR DTC P1326 (PI1802W/X)

This bulletin provides information related to the Technical Service Bulletin previously published in July 2018 ([PI1802](#), Rev 6, 01/31/2019) titled “Knock Sensor Detection System - ECU Logic Improvement”. Specifically, this bulletin provides instructions on which procedures to follow if, after installation of the KSDS, any one of the subject vehicles below returns to the dealer with Diagnostic Trouble Code (“DTC”), P1326.

Year	Model	Engine	Production Date
2014	Optima (TF)	2.4L GDI	8/29/13 – 4/25/14
2015-2018	Optima (TF/QF/JF/JFa)	2.4L & 2.0L T-GDI	4/16/14 – 7/11/18
2014-2018	Sportage (SL/QL)	2.4L & 2.0L T-GDI	9/30/13 – 4/5/18
2015-2018	Sorento (XMa/UMa)	2.4L & 2.0L T-GDI	1/3/14 – 3/7/18

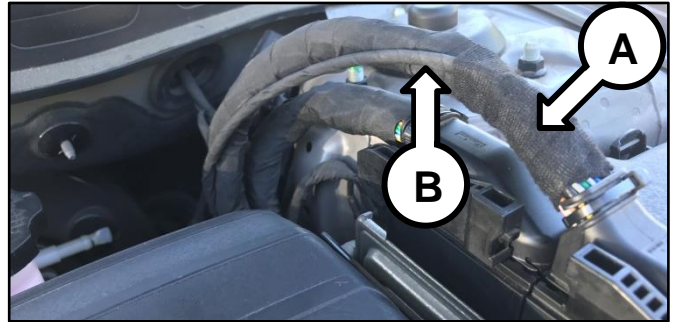
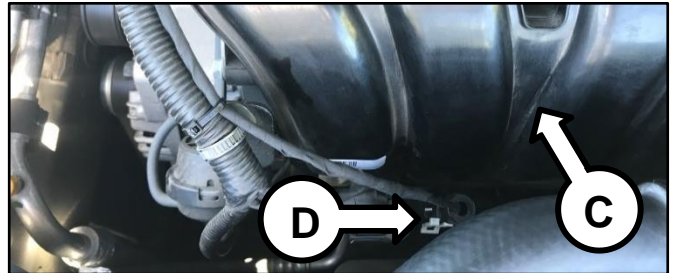
**NOTE:** To identify the extension harness (B), look for an external harness (B) which should be cable-tied to the existing wiring harness (A) leading by the intake manifold (C) to the knock sensor (D), as shown.

- If the extension harness (B) has been installed, open a Techline case online.
- If the extension harness (B) has not been installed, proceed to the next step.
