GROUP Product Improvement	MODEL 2014-2016MY Soul (PS) w/Nu 2.0L GDI
	NUMBER 2002B (Rev 2, 01/21/2021)	DATE August 2020
PRODUCT IMPROVEMENT CAMPAIGN		
SUBJECT: NU 2.0L GDI - KNOCK SENSOR DETECTION SYSTEM (KSDS) ECU UPGRADE (PI2002B)

NU 2.0L GDI - KNOCK SENSOR DETECTION SYSTEM (KSDS) ECU UPGRADE (PI2002B)

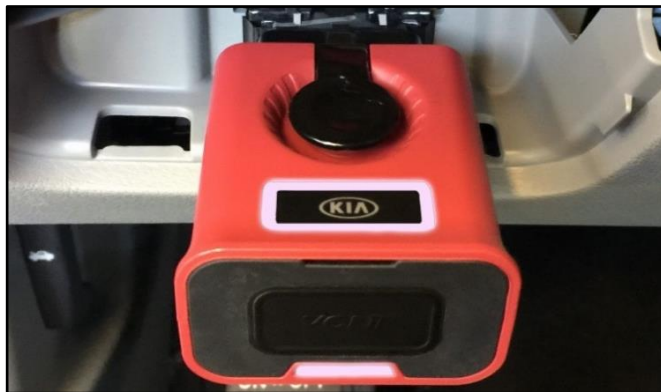
The ECU upgrade function on KDS operates wirelessly. It is not necessary to perform the upgrade via USB cable.

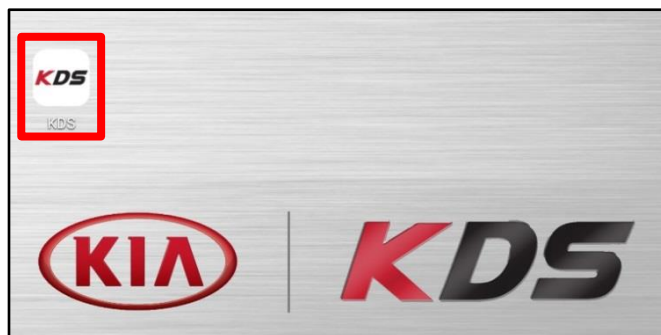
2. With the ignition ON, turn ON the KDS tablet. Select **KDS** from the home screen.
