## SERVICE BULLETIN

**APPLICABILITY:** 2013MY and Later Impreza Models  
 2013MY and Later XV Crosstrek™ Models

**NUMBER:** 01-171-13

**SUBJECT:** Additional PDI Procedure for Installation of  
 Tie-Down Hole Plugs

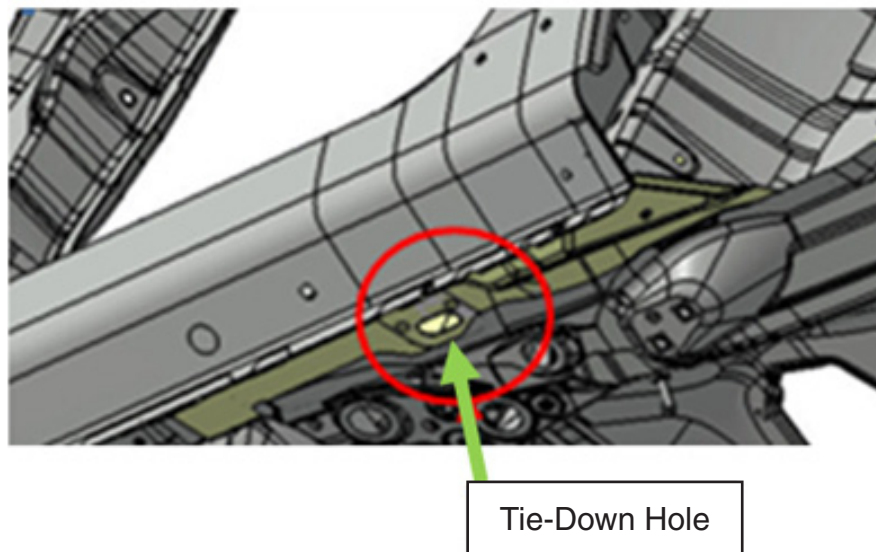
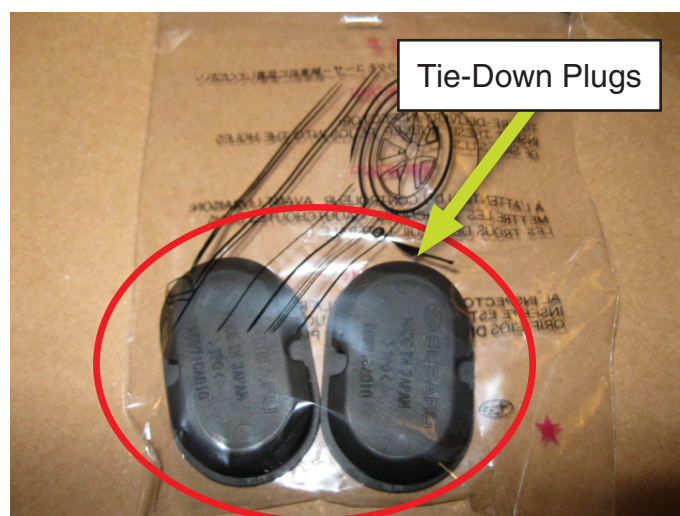
The illustration below shows the location ahead of the rear wheel arch for installation of the additional tie-down plugs which are provided for both sides of the vehicle.

Beginning with the VIN numbers listed in the chart below, body plugs must be installed into the tie-down holes on both sides of the vehicle during PDI. The plugs are placed in the vehicle's glove box during port processing. The installation of these plugs eliminates these openings as a source of dust intrusion into the vehicle.
