December 19, 2015

02517 Version 2

Safety Recall: Front Passenger's Airbag Inflator Can Be Over-Pressurized

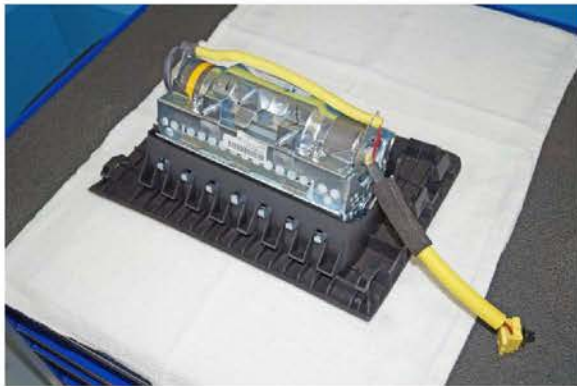
4. Place the airbag, face-down, on a clean shop towel.

- The orientation of the airbag is critical because if the inflator is installed incorrectly, the harness will be too short when you reinstall the airbag.
- The brackets between the various models are similar but may differ from the example shown.

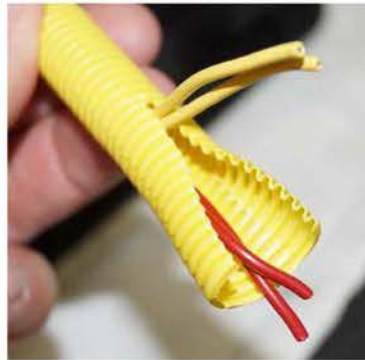
- Cut about 2 inches of the corrugated tube, then pull out the yellow wires.

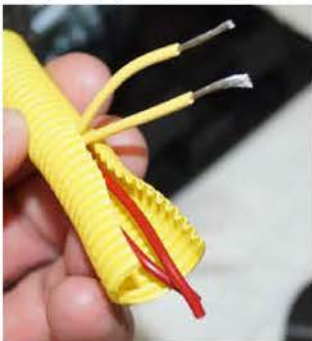
- Strip away about an inch of the wire insulation, then twist the wire ends together.

- Tape the twisted ends with electrical tape.

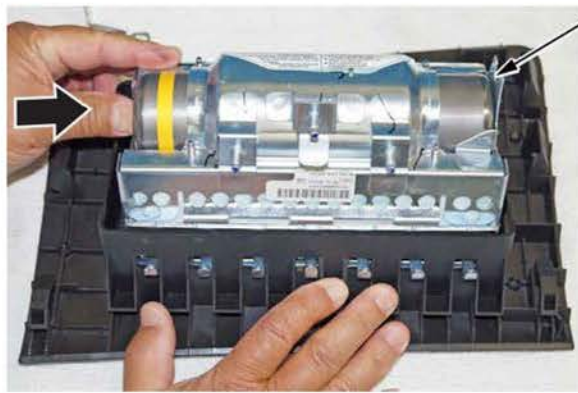
- Slide the inflator in until the "D" aligns with the tab on the inflator bracket. There should be no space or gap between the inflator and bracket.

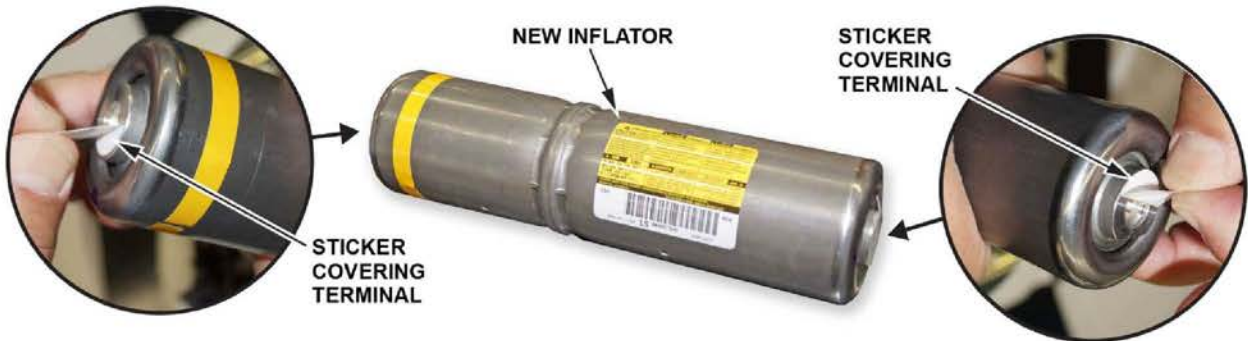
15. Remove the stickers covering the terminals on both sides of the new inflator.
